FEASIBILITY REPORT

on Improvements to the
Cannon Valley Trail

Presented to the
Cannon Valley Trail
Joint Powers Board

January 13, 2017

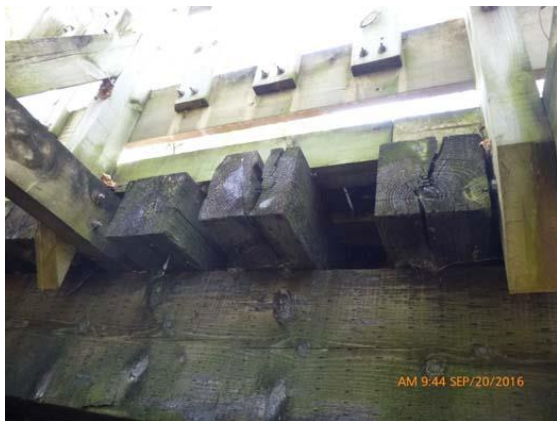
The approaches have been recently patched due to settlement of the bituminous at the abutments. The deck planks have moderate deterioration but are holding well, there are patches where the ends of some deck planks have been replaced near the curbs. A few curb sections are splitting and / or are loose. The railing is in relatively good condition with minor weathering and staining. The floor beams are splitting and failing throughout.

Figure 1.1 Floor Beams - Splitting and failing floor beams throughout the structure.

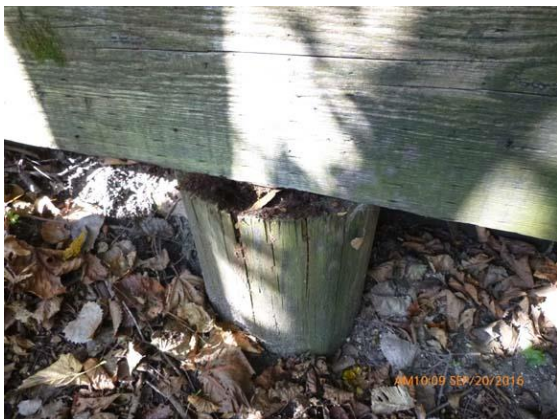
The west abutment is in relatively good condition. It appears that the backing planks have large enough gaps between them to allow finer sand and material to escape from behind the abutment; this could be a contributing factor to the bituminous settlement above. The south most pile is rotting and becoming hollow.

Figure 1.2 West Abutment - South pile rotting and becoming hollow.

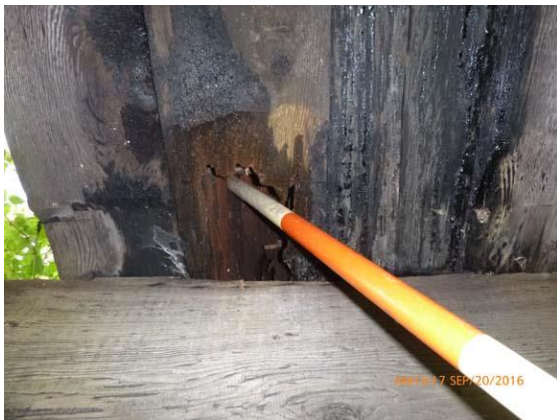
Figure 1.9 Pier 7 - Beam section loss and rot at bearing.

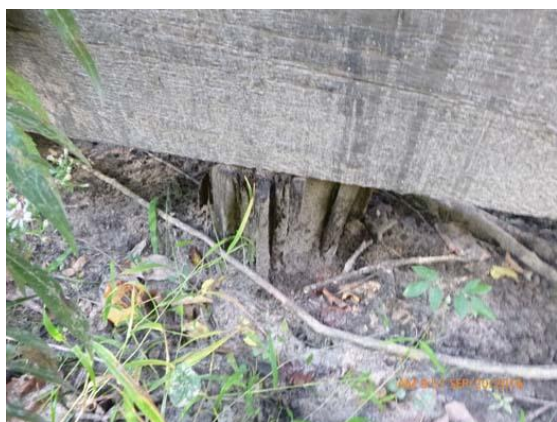
Figure 1.10 Pier 7 - Pile rotting through.

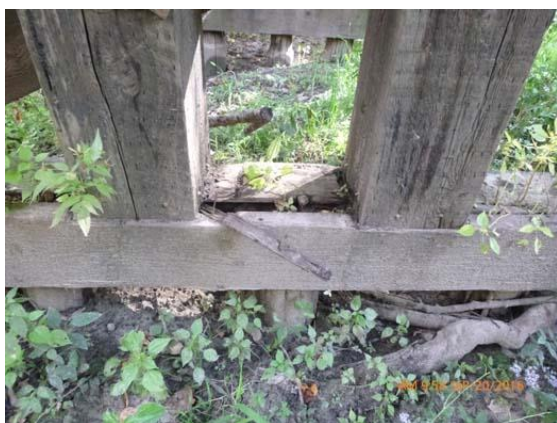
Figure 1.11 Pier 7 - Rot and significant section loss of bottom pile cap.

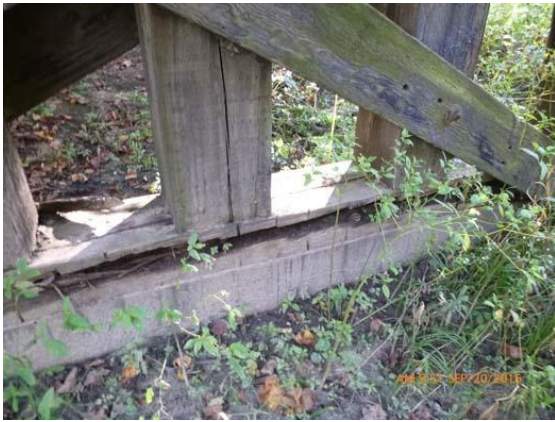
Figure 1.13 Pier 9 - Rot and severe section loss of bottom pile cap.

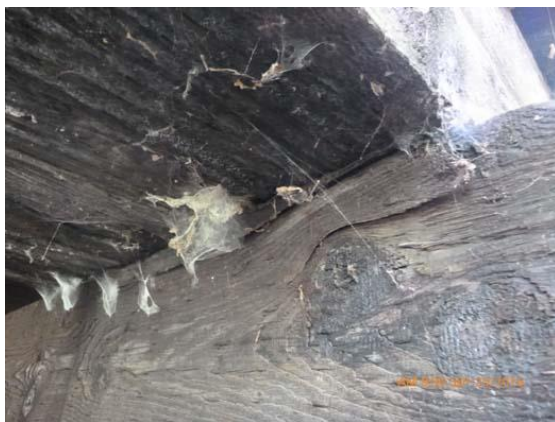
Figure 1.14 Pier 9 - Local crushing of the pier cap under beam.

There are several options for replacement alternatives. A single-span or two-span steel truss bridge with a reinforced concrete deck can be used. In addition, a multi-span longitudinally-laminated timber panel bridge that can be paved with a smooth bituminous wear course is also a feasible option. The recommended options can include different rail configurations depending on the preference of the CVT Board. Regardless, ongoing repairs may become necessary and therefore routine inspections should be performed to monitor this structure until its replacement.

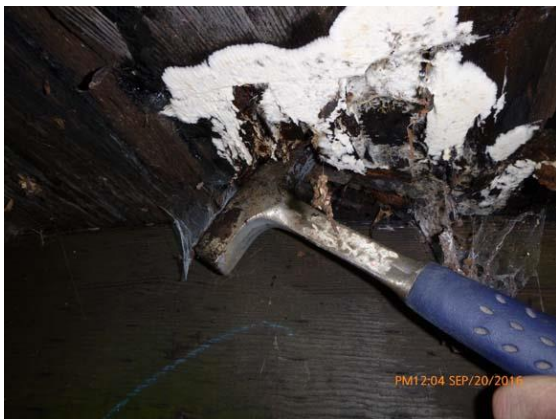
Figure 2.1 Beams - Section loss and rot at bearing area.

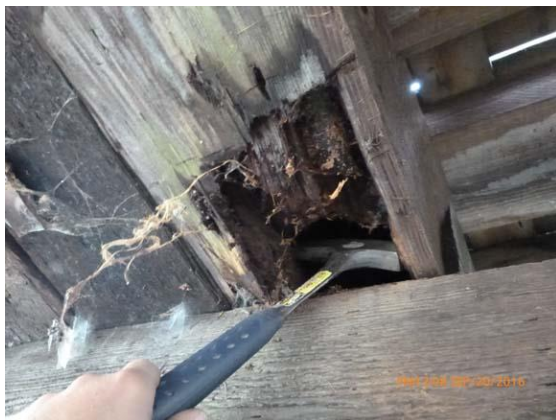
Figure 2.2 Beams - Section loss and rot at bearing areas.

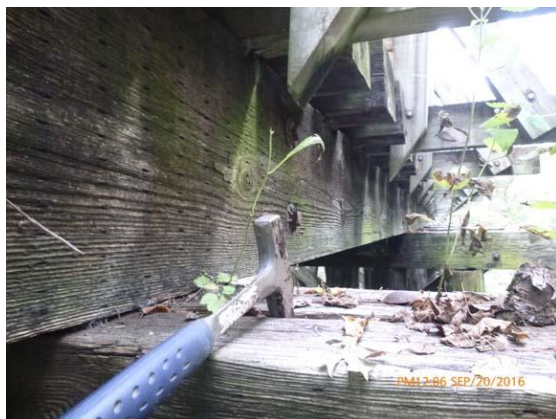
Figure 2.3 Piers - Splitting and decay of pile caps.

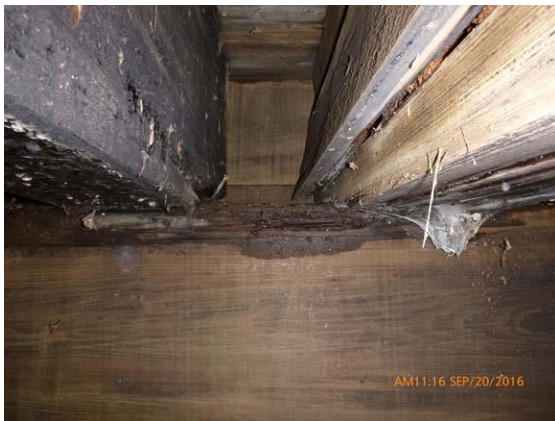
The pile cap at the west abutment is rotting and has locally crushed under the center stringers. The planks are allowing granular material to escape from under them. Most piles are splitting and rotting.

Figure 3.1 Pile cap - The cap is rotting and starting to crush under the center stringers of the west abutment. Also note the longitudinal splits and decay on the stringers.

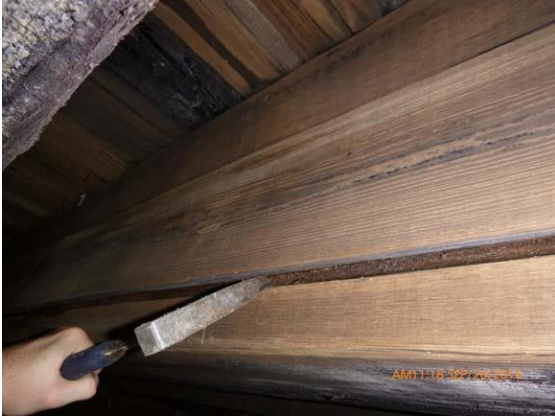
Figure 3.3 Beams - Longitudinal splits and decay on beams.

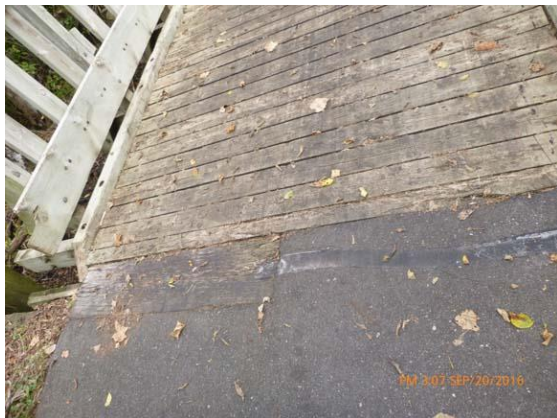
Figure 4.1 Approach - Wood plank used to patch bituminous approach.

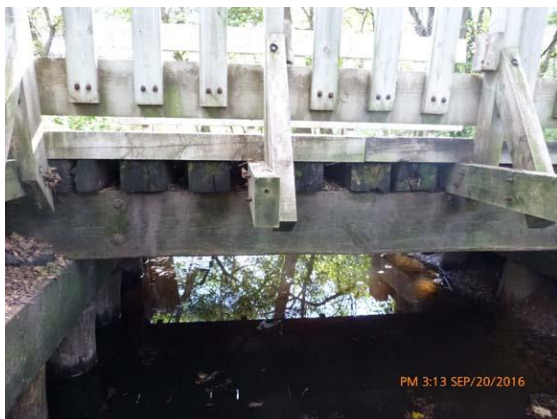
Figure 4.2 Deck - Floor beams failing and splitting.

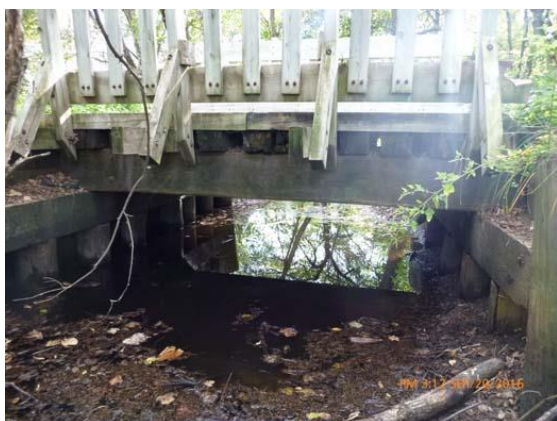
Figure 4.3 Abutments - Deteriorated and splitting piles.

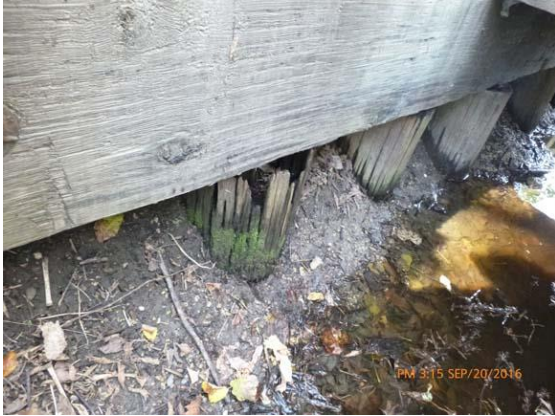
Both abutments have decay at the top of the pile caps towards the ends. The piles are decaying, splitting, and becoming hollow at the top on both abutments. At the west abutment the first pile from the south has completely failed, and the second has about 80% section loss.

Figure 4.4 West abutment - Piles with major section loss.

Widening or rehabilitating this bridge beyond minor localized deck and rail repairs is not recommended. The floor beams and abutment piles need to be monitored for decay. When it is determined that the decaying piles and floor beams are no longer adequate, a full replacement is recommended. This bridge could be replaced by a 12x4 ft precast box culvert. A longitudinally-laminated timber slab bridge is also a good option since it has a thin structure depth and can be paved with a smooth bituminous wear course. Different rail configurations can be installed depending on the preference of the CVT Board if a bridge option is desired. Regardless, ongoing repairs may become necessary and therefore routine inspections should be performed to monitor this structure until its replacement.

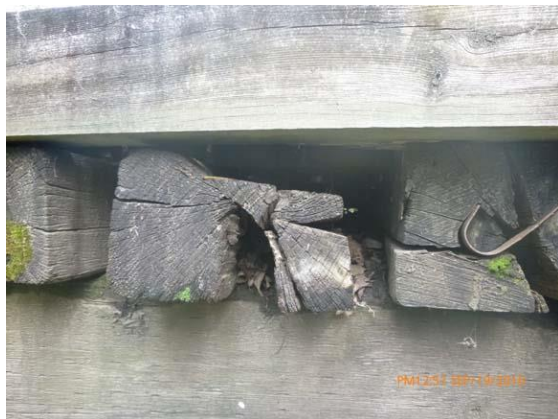
Figure 5.2 Floor beams - Failed floor beams throughout.

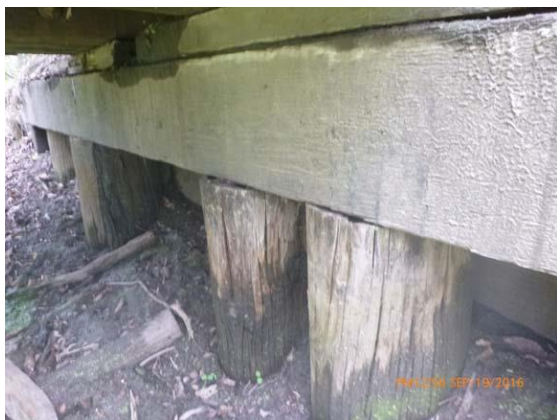
At the east abutment the pile cap has minor section loss at the ends and the bearing spacers are decaying. All piles are decaying and showing signs of section loss and rot.

Figure 5.4 East abutment - Rotting and splitting piles becoming hollow.

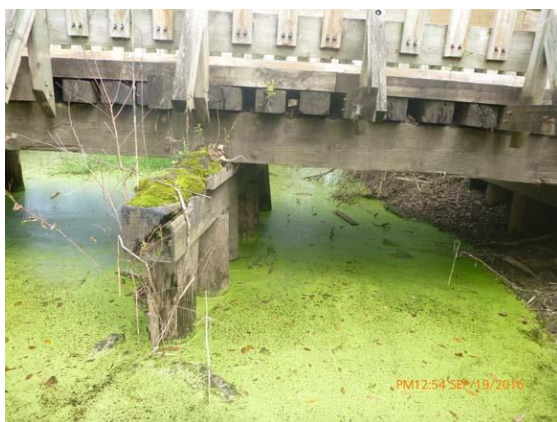
Figure 5.5 Pier 4 - Rotting pier cap and pile. Note minor impact damage on both fascia stringers.

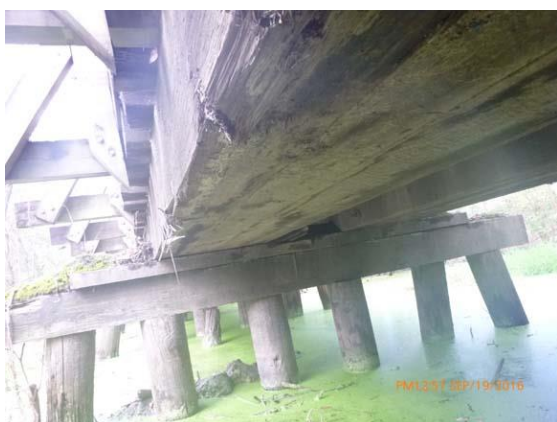
Figure 5.6 Pier 4 - Bearing spacers shifting. Note minor impact damage on fascia stringer.

Widening or rehabilitating this bridge beyond minor localized deck and rail repairs is not recommended, since most piles are showing section loss, the abutments are moving, bearing spacers are shifting, and the pile caps are rotting. When it is determined that the decaying components are no longer adequate, a full replacement is recommended. The main beams can be salvaged for other projects after close inspection to verify their apparent good condition. A single-span steel truss bridge with a reinforced concrete deck can be used. A multi-span longitudinally-laminated timber slab bridge is also a good option since it has a thin structure depth and can be paved with a smooth bituminous wear course. Different rail configurations can be installed depending on the preference of the CVT Board. Regardless, ongoing repairs may become necessary and therefore routine inspections should be performed to monitor this structure until its replacement.

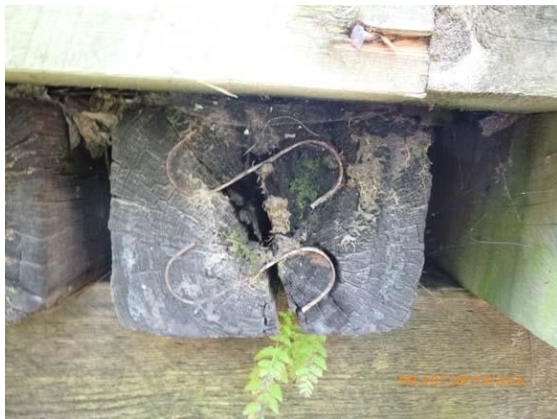
Figure 6.1 Floor beams - Typical floor beam failure due to rot.

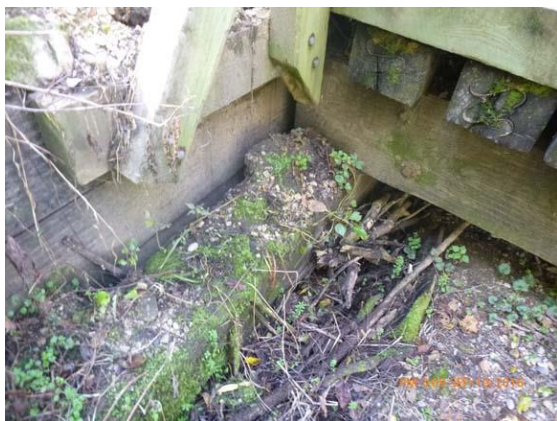
Figure 6.2 West abutment - Cap partially buried and starting to decay.

The west abutment piles are mostly buried; the exposed portions of the piles exhibit decay and splitting. The backing plank pile on the north side is hollowed out. The cap is getting buried, and has moderate decay and rot on the north side.

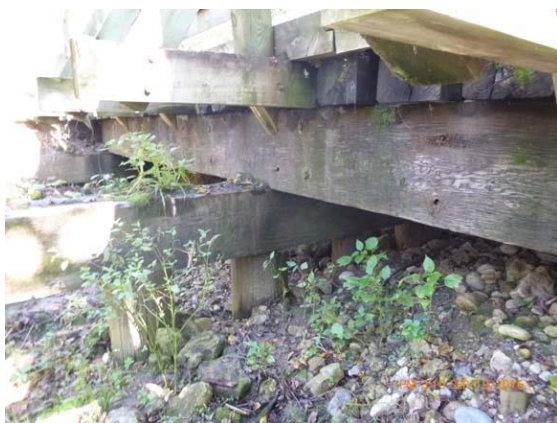
Figure 6.3 Pier - Cap decaying and rotting, and piles becoming hollow.

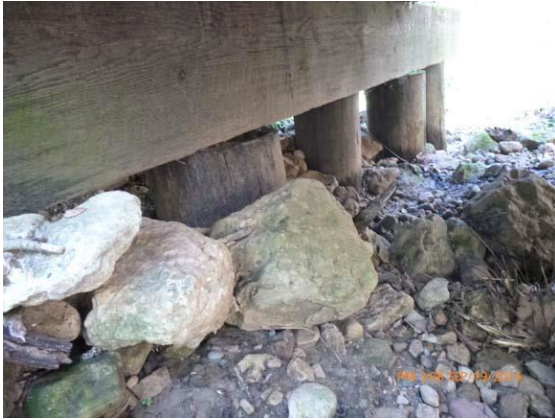
Figure 6.4 Pier - Piles becoming hollow.

Since all the components of the substructure and superstructure are deteriorated, a complete replacement is advised since the lifespan of the existing components will not be adequate for the lifespan of a possible retrofit. Widening or rehabilitating this bridge beyond minor localized deck and rail repairs is therefore not recommended. The main beams can be salvaged for other projects after close inspection to verify their apparent good condition. We recommend this bridge be replaced with a two-line 12x4 ft precast box culvert. A single-span longitudinally-laminated timber slab bridge is also a good option since it has a thin structure depth

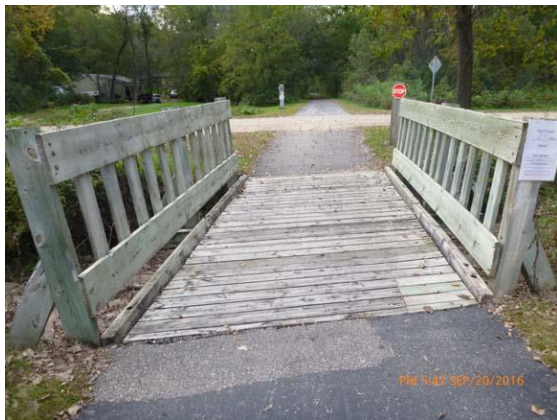
Figure 7.1 Deck - Bituminous and deck patches. Note how the southeast corner is slightly lower.

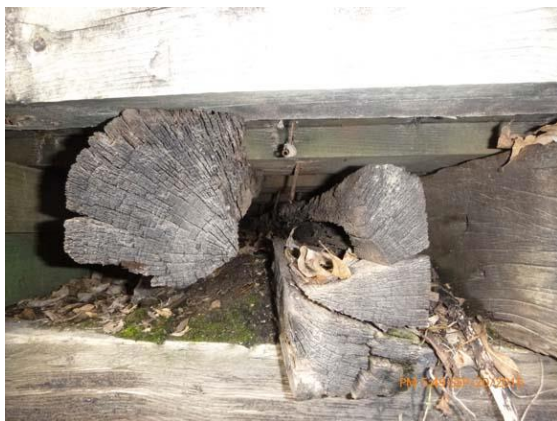
Figure 7.2 Floor beams - Typical floor beam failure due to rot.

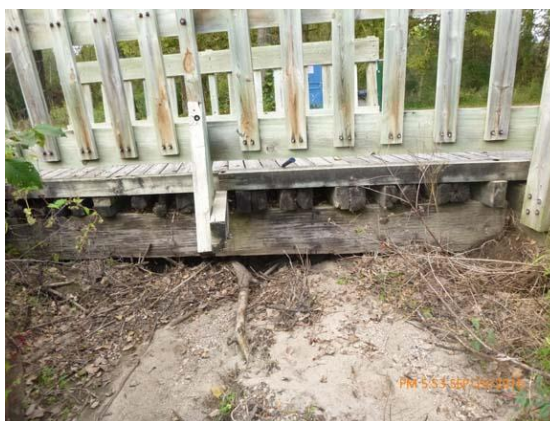
Figure 7.3 Looking north - Buried abutments and failed floor beams.

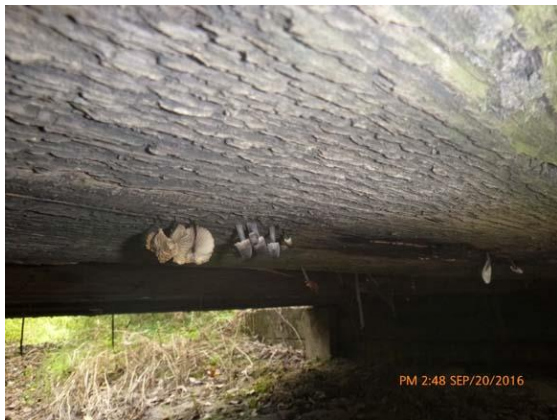
Figure 8.1 Beam - Deterioration and section loss of north stringer.

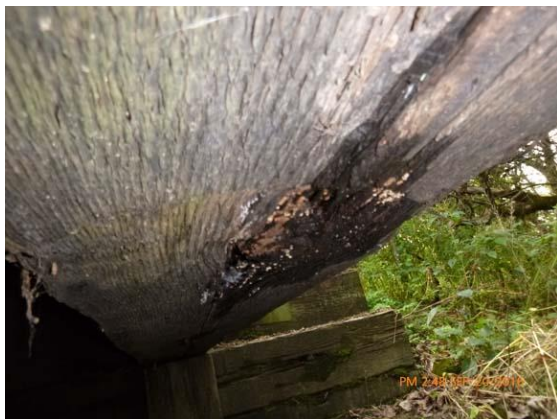
Figure 8.2 Beam - Deterioration and section loss of north stringer.

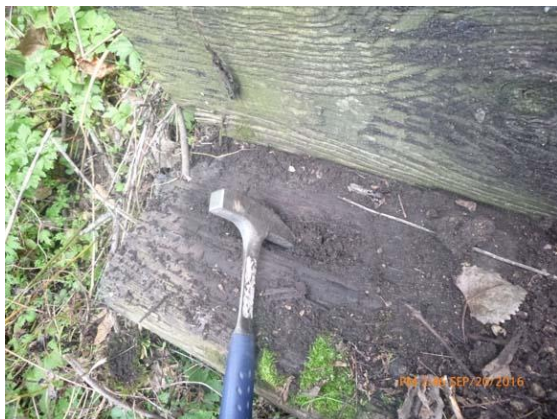
Figure 8.3 Footings - Section loss at the top on all corners.

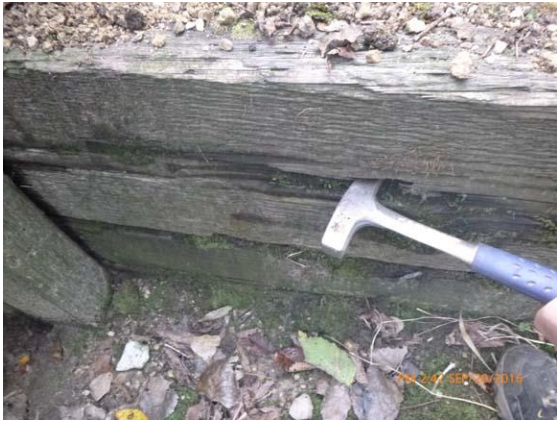
Figure 8.4 Footings - Section loss at the front on all corners.

Widening or rehabilitating this bridge beyond minor localized deck and rail repairs is not recommended. Primarily the north-most beam and the abutment caps need to be monitored for decay. When the time comes to replace the beam and / or caps, a full replacement is recommended. This bridge could be replaced by a precast 14x4 ft box culvert. A longitudinally-laminated timber slab bridge is also a good option since it has a thin structure depth and can be paved with a smooth bituminous wear course. Different rail configurations can be installed depending on the preference of the CVT Board if a bridge option is desired. Regardless, ongoing repairs may become necessary and therefore routine inspections should be performed to monitor this structure until its replacement.

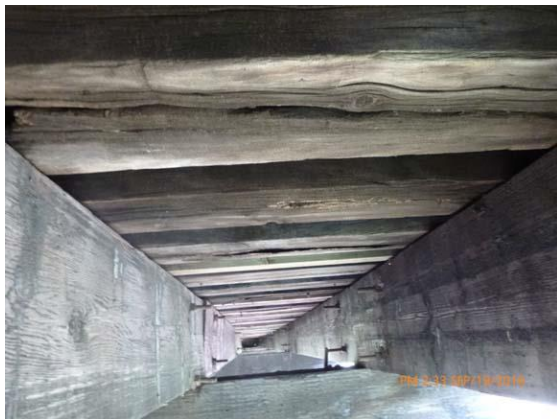
Figure 9.1 Floor beams - Typical floor beam failure due to rot.

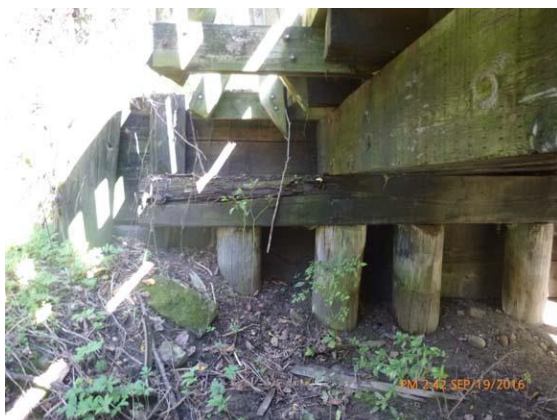
Figure 9.2 East abutment - Cap splitting and decaying.

The east abutment pile cap is showing decay at the ends, with a severe split and generalized rot on the north end. The north most pile holding the planks is hollow and rotted. The second pile from the south has advanced decay.

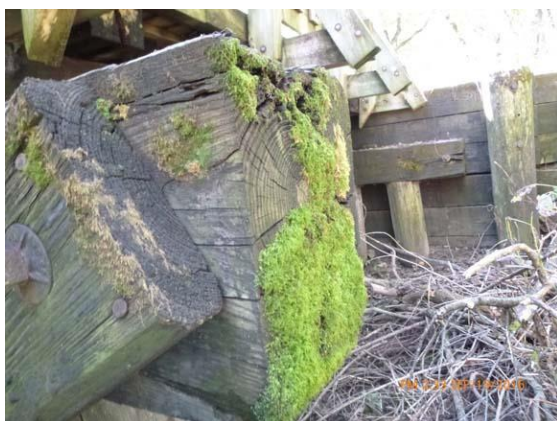
Figure 9.3 Pier 1 - Decay on pile cap ends.

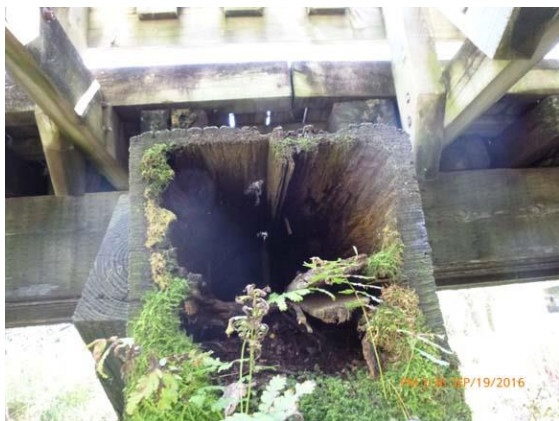
Figure 9.4 Pier 2 - Major decay and section loss on pile cap.

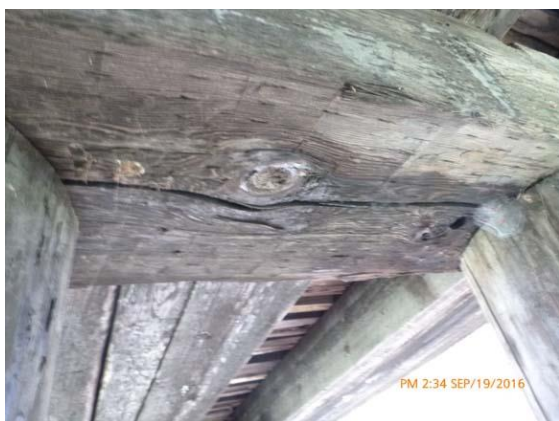
Figure 9.5 Pier 3 - Major splitting of the pile cap.

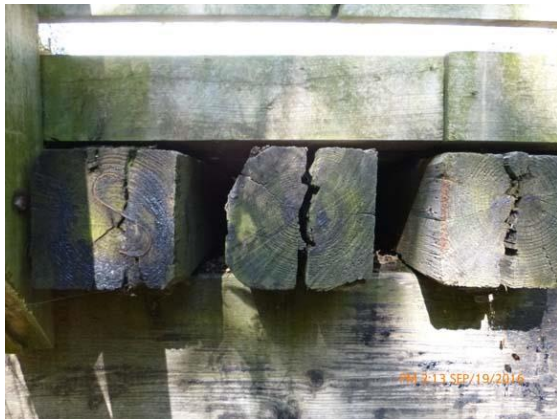
Figure 10.1 Floor beams - Typical floor beam failure due to rot.

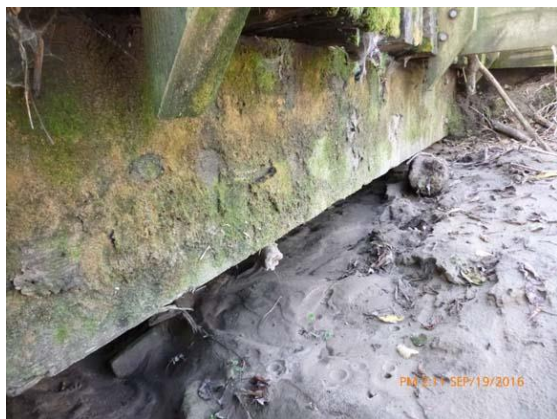
Figure 10.2 Beam - Active moss on beam. Note the buried footing.

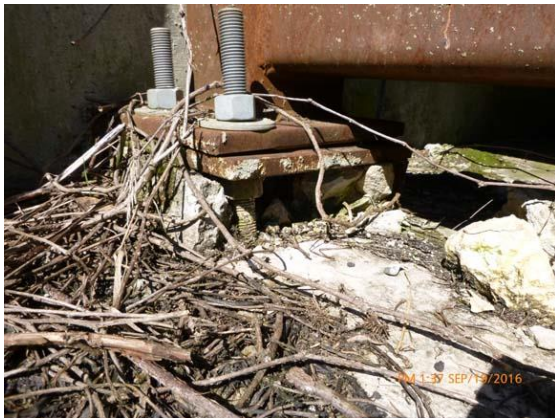
Figure 11.1 Southwest bearing - Bent anchor rods and spalled grout.

This structure is in good condition. The bearings on the west abutment should be rehabilitated soon in order for them to function as intended. Monitoring the movement of the abutment should be done routinely.

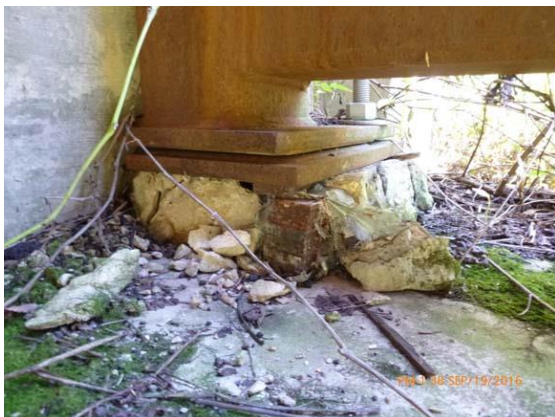
Figure 11.2 Northwest bearing - Bent anchor rods and spalled grout.

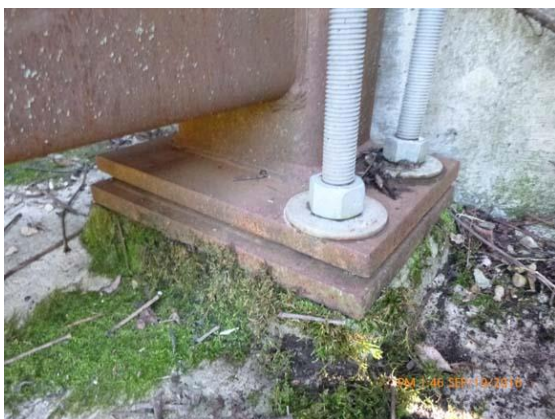
Figure 11.3 Southeast bearing - Grout with minor deterioration.

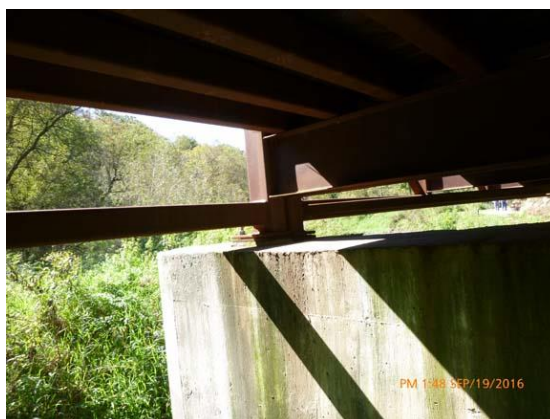
Figure 11.4 Pier bearing - Grout in good condition.

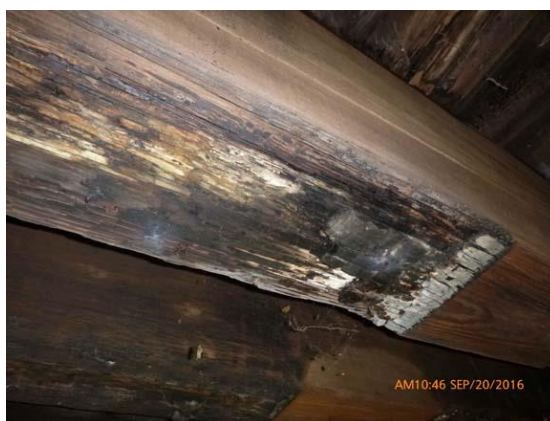
Figure 12.4 Stringers - Minor fire damage.

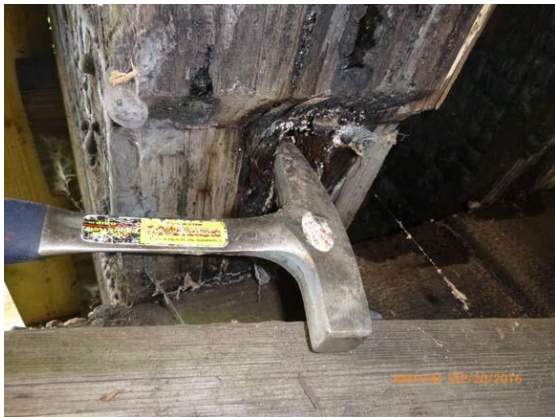
Figure 12.5 Stringers - Minor section loss at pier bearing.

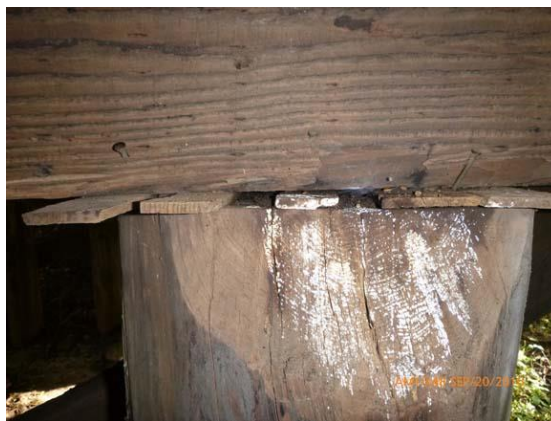
Figure 12.8 Piles - Rotting shims between piles and cap.

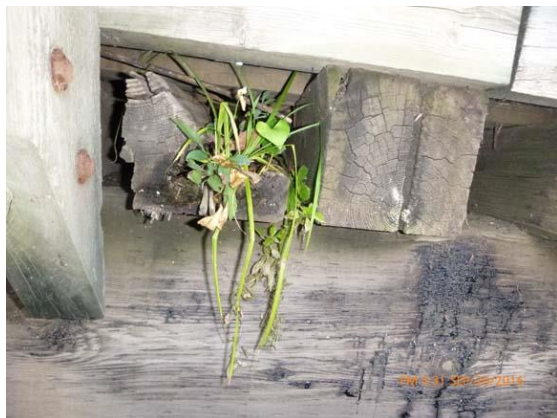
Figure 13.2 Floor beams - Typical floor beam failure due to rot.

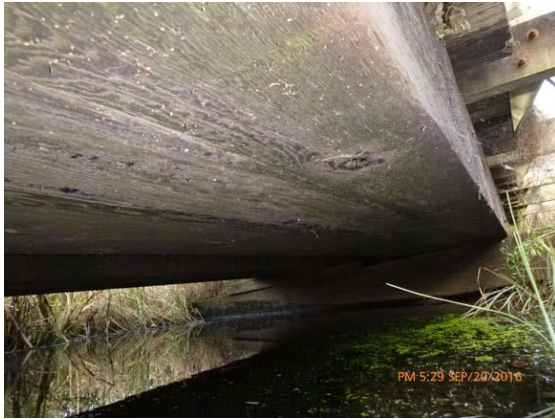
Figure 13.4 Beams - Beams in good condition. Note how the north beam bearing spacer has shifted slightly at Pier 2.

Rehabilitating this bridge and widening it is possible since the piles are in good condition. The recommended option is to install a transversely-laminated deck that can be paved with a smooth bituminous wear course. For this to be a long term solution and to ensure that the existing components are adequate for the design life span of the retrofit, removing the deck, rails, curbs and floor beams is necessary, then all the wingwalls will have to be completely replaced and potentially also the east pier cap. The rest of the substructures and the main beams can be reused with the proposed timber deck

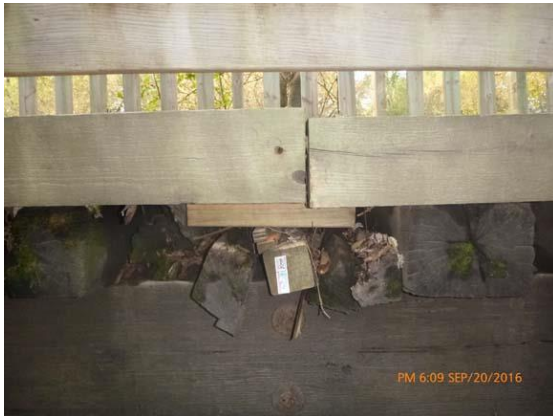
Figure 14.1 Floor Beam - Failed floor beam and patch.

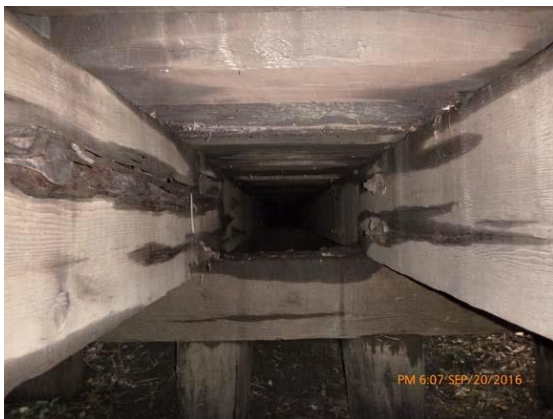
Figure 14.2 Beams - Minor decay along the inside of interior stringers.

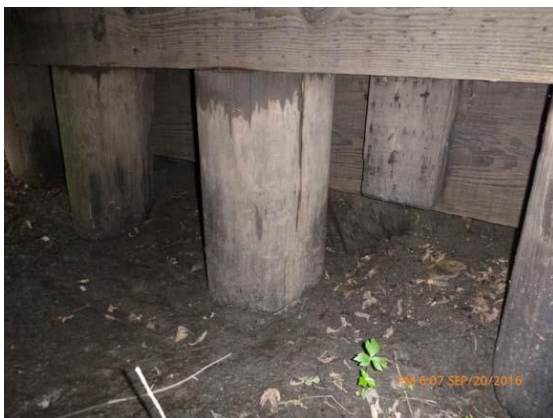
The east abutment has minor undermining at its center where soil is coming out from under the backing planks. The pile cap is splitting along its entire length. The north wingwall is rotating forward and failing. The piles have minor decay and splits throughout.

Figure 14.3 East abutment - Minor undermining under backing planks.

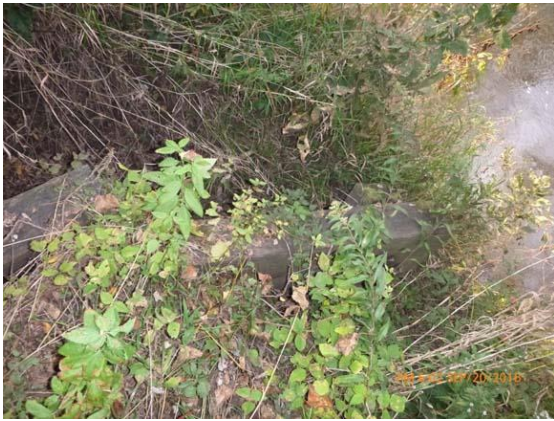
Figure 14.5 Northeast wingwall - the wall is rotating forward and failing.

The single-span option is preferred due to the site characteristics and soil accumulation around the bridge. It is recommended to remove the existing soil accumulated on the south and north sides of the bridge and then riprap the north side towards the Cannon River. Different rail configurations can be installed depending on the preference of the CVT Board. Regardless, routine inspections should be performed to monitor this structure.

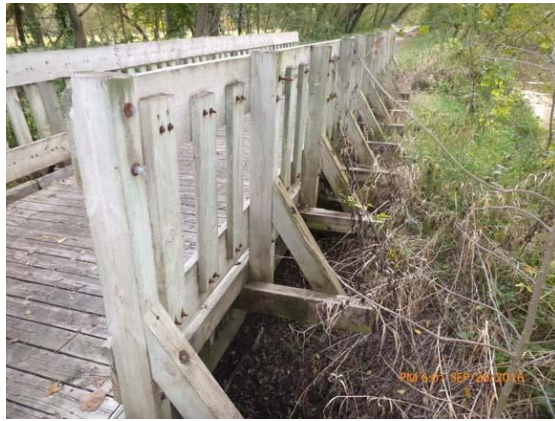
Figure 14.6 North side - Berm affecting water flow.

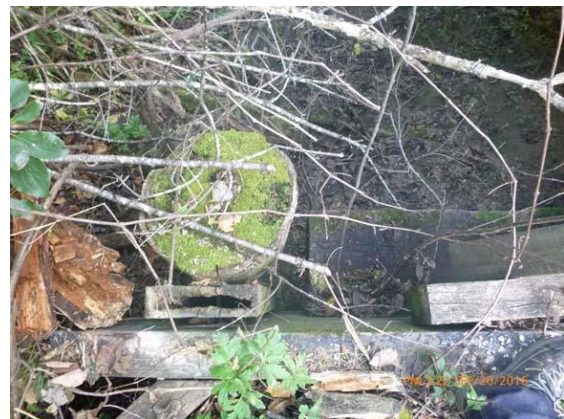
Figure 15.3 West abutment - Rotting and hollow backing plank spacer.

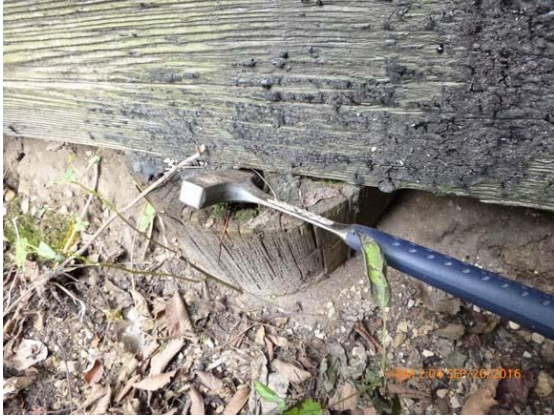
Figure 15.4 East abutment - Top of pile rotting and becoming hollow.

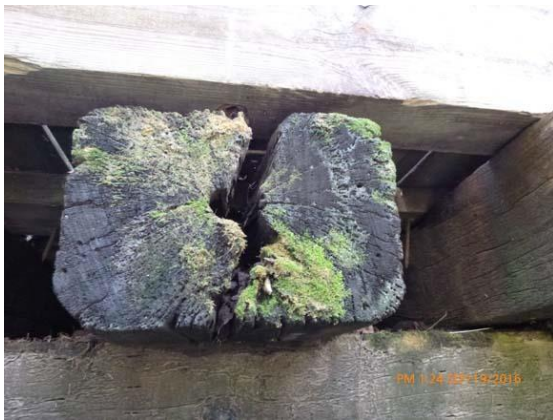
Figure 16.1 Floor beam - Typical floor beam failure due to rot.

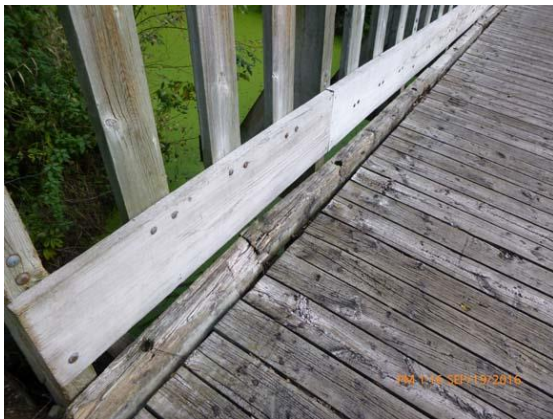
Figure 16.2 Deck - Decaying curb sections.

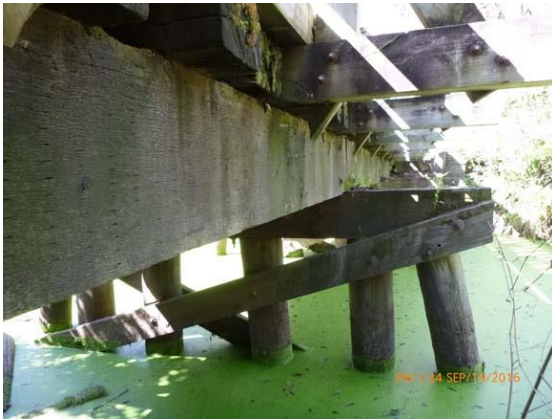
Figure 16.3 Looking West - Piers and beams in good condition. Note the generalized failure of the floor beams.

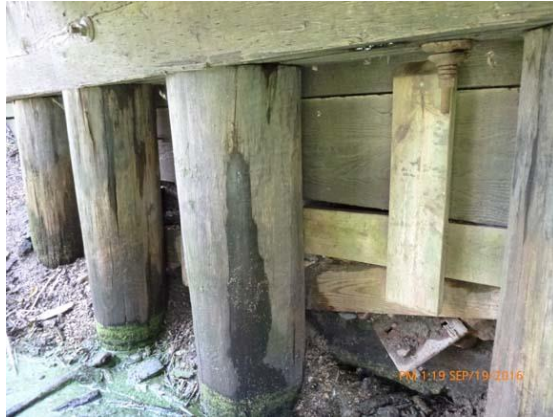
Figure 16.4 East abutment - failed backing planks and patches.

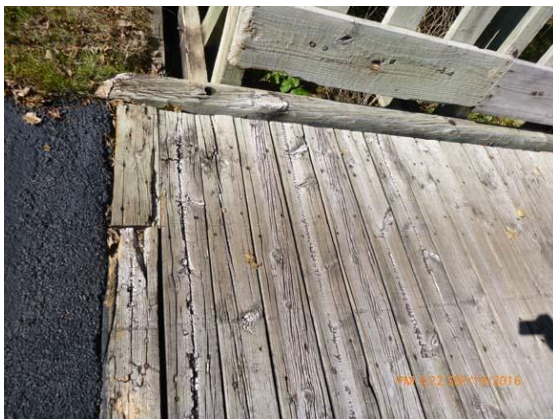
Figure 17.1 Deck - Planks rotting towards the end of deck.

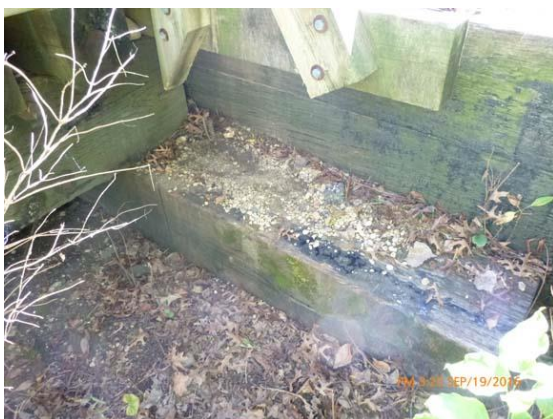
Figure 17.2 West abutment - Piles and cap are partially buried.

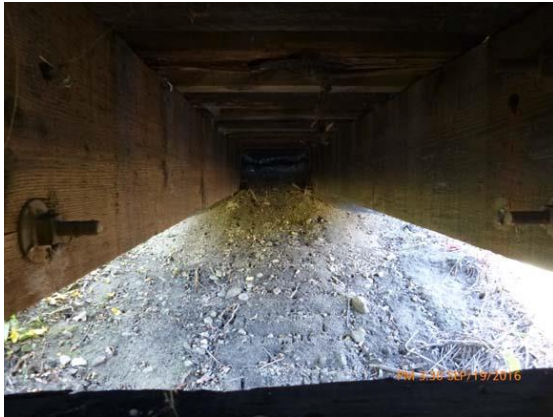
Figure 17.3 East abutment - Piles are completely buried and cap is partially buried.

Most of the decay and damage is affecting the floor beams and pile caps. A solution for rehabilitating this bridge and widening it at the same time is to install a transversely-laminated timber deck that can be paved with a smooth bituminous wear course. For this to be a long term solution and to ensure that the existing components are adequate for the design life span of the retrofit, removing the deck, rails, curbs and floor beams will be necessary, also replacing the pile caps. The rest of the substructures and the main beams can be reused with the proposed timber deck placed on top. Since the rehabilitation efforts will be extent for this bridge, there are several full

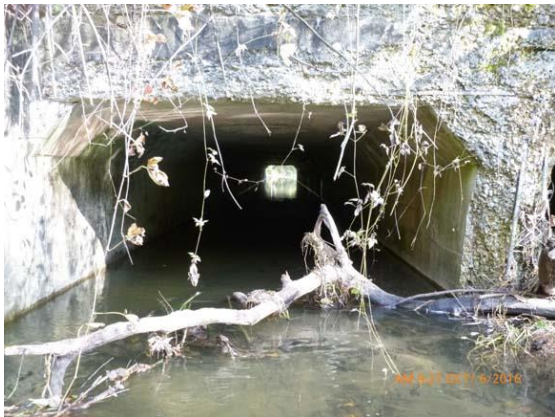
Figure 18.1 South Head Wall - Extensive damage to headwall with exposed rebar, and spalling of the barrel ceiling.

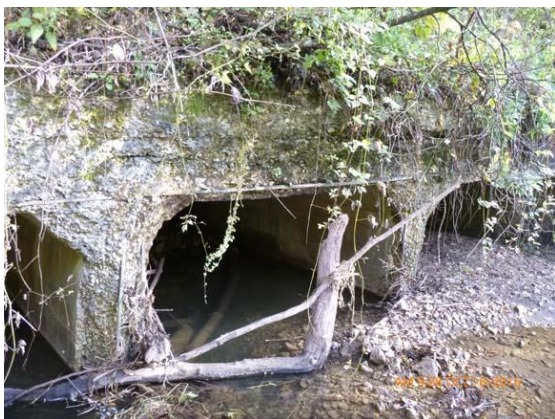
Figure 18.2 South Head Wall - Extensive damage to headwall with exposed rebar, and debris accumulation along center and east barrels.

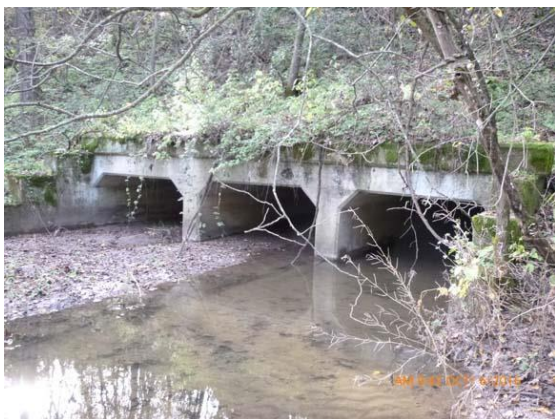
Figure 18.3 North Head Wall - Headwall in good condition.

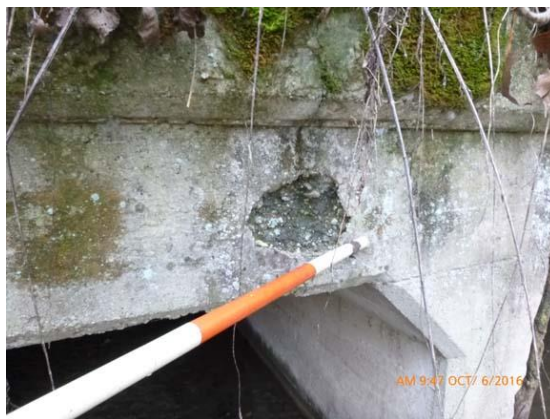
Figure 18.4 North Head Wall - Moderate spall over center barrel.

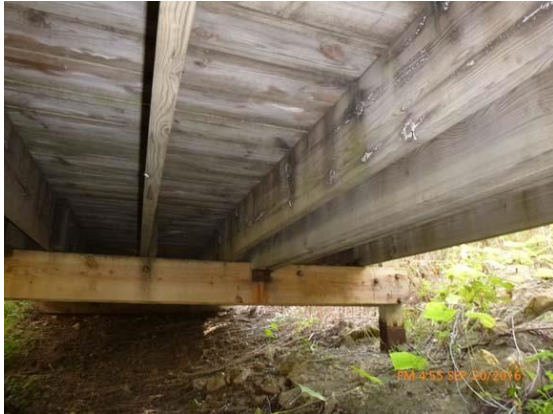
Figure 19.1 Beams - Minor weathering throughout. Note the staining due to rusting of the beam brackets.

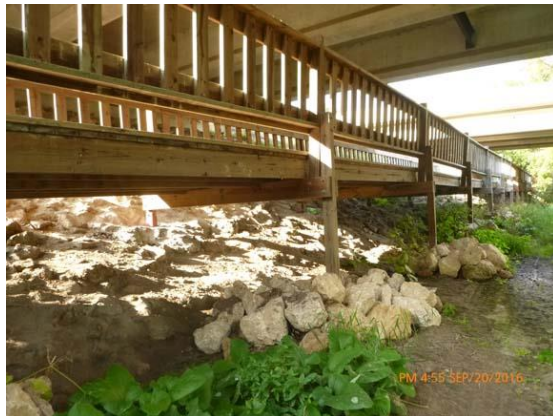
Figure 19.2 Piers - Riprap placed at the base of the posts holding well.

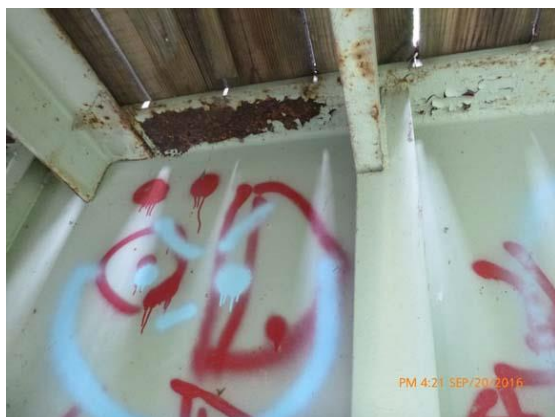
Figure 20.3 Beam - Typical localized paint system failure.

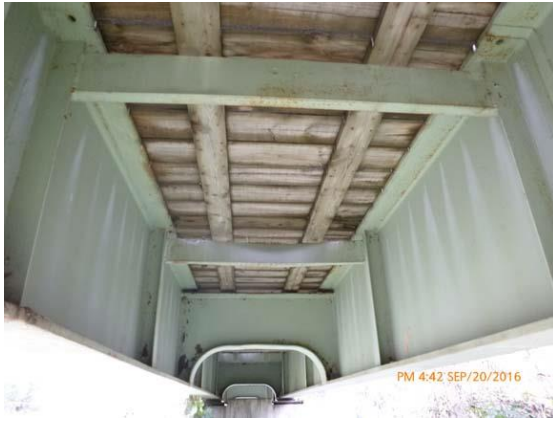
Figure 20.4 Diaphragms - Note the slight bending of the diaphragm at the center of the picture.
