To:	Scott Roepke Cannon Valley Trail Association	From:	Gary Morien Authors: Gary Morien, John Smyth, Mark Statz, Dan Edgerton
File:	Stantec Project No. 193801880	Date:	August 22, 2013

Reference: Technical Memorandum - Cannon Valley Trail Erosion Repairs

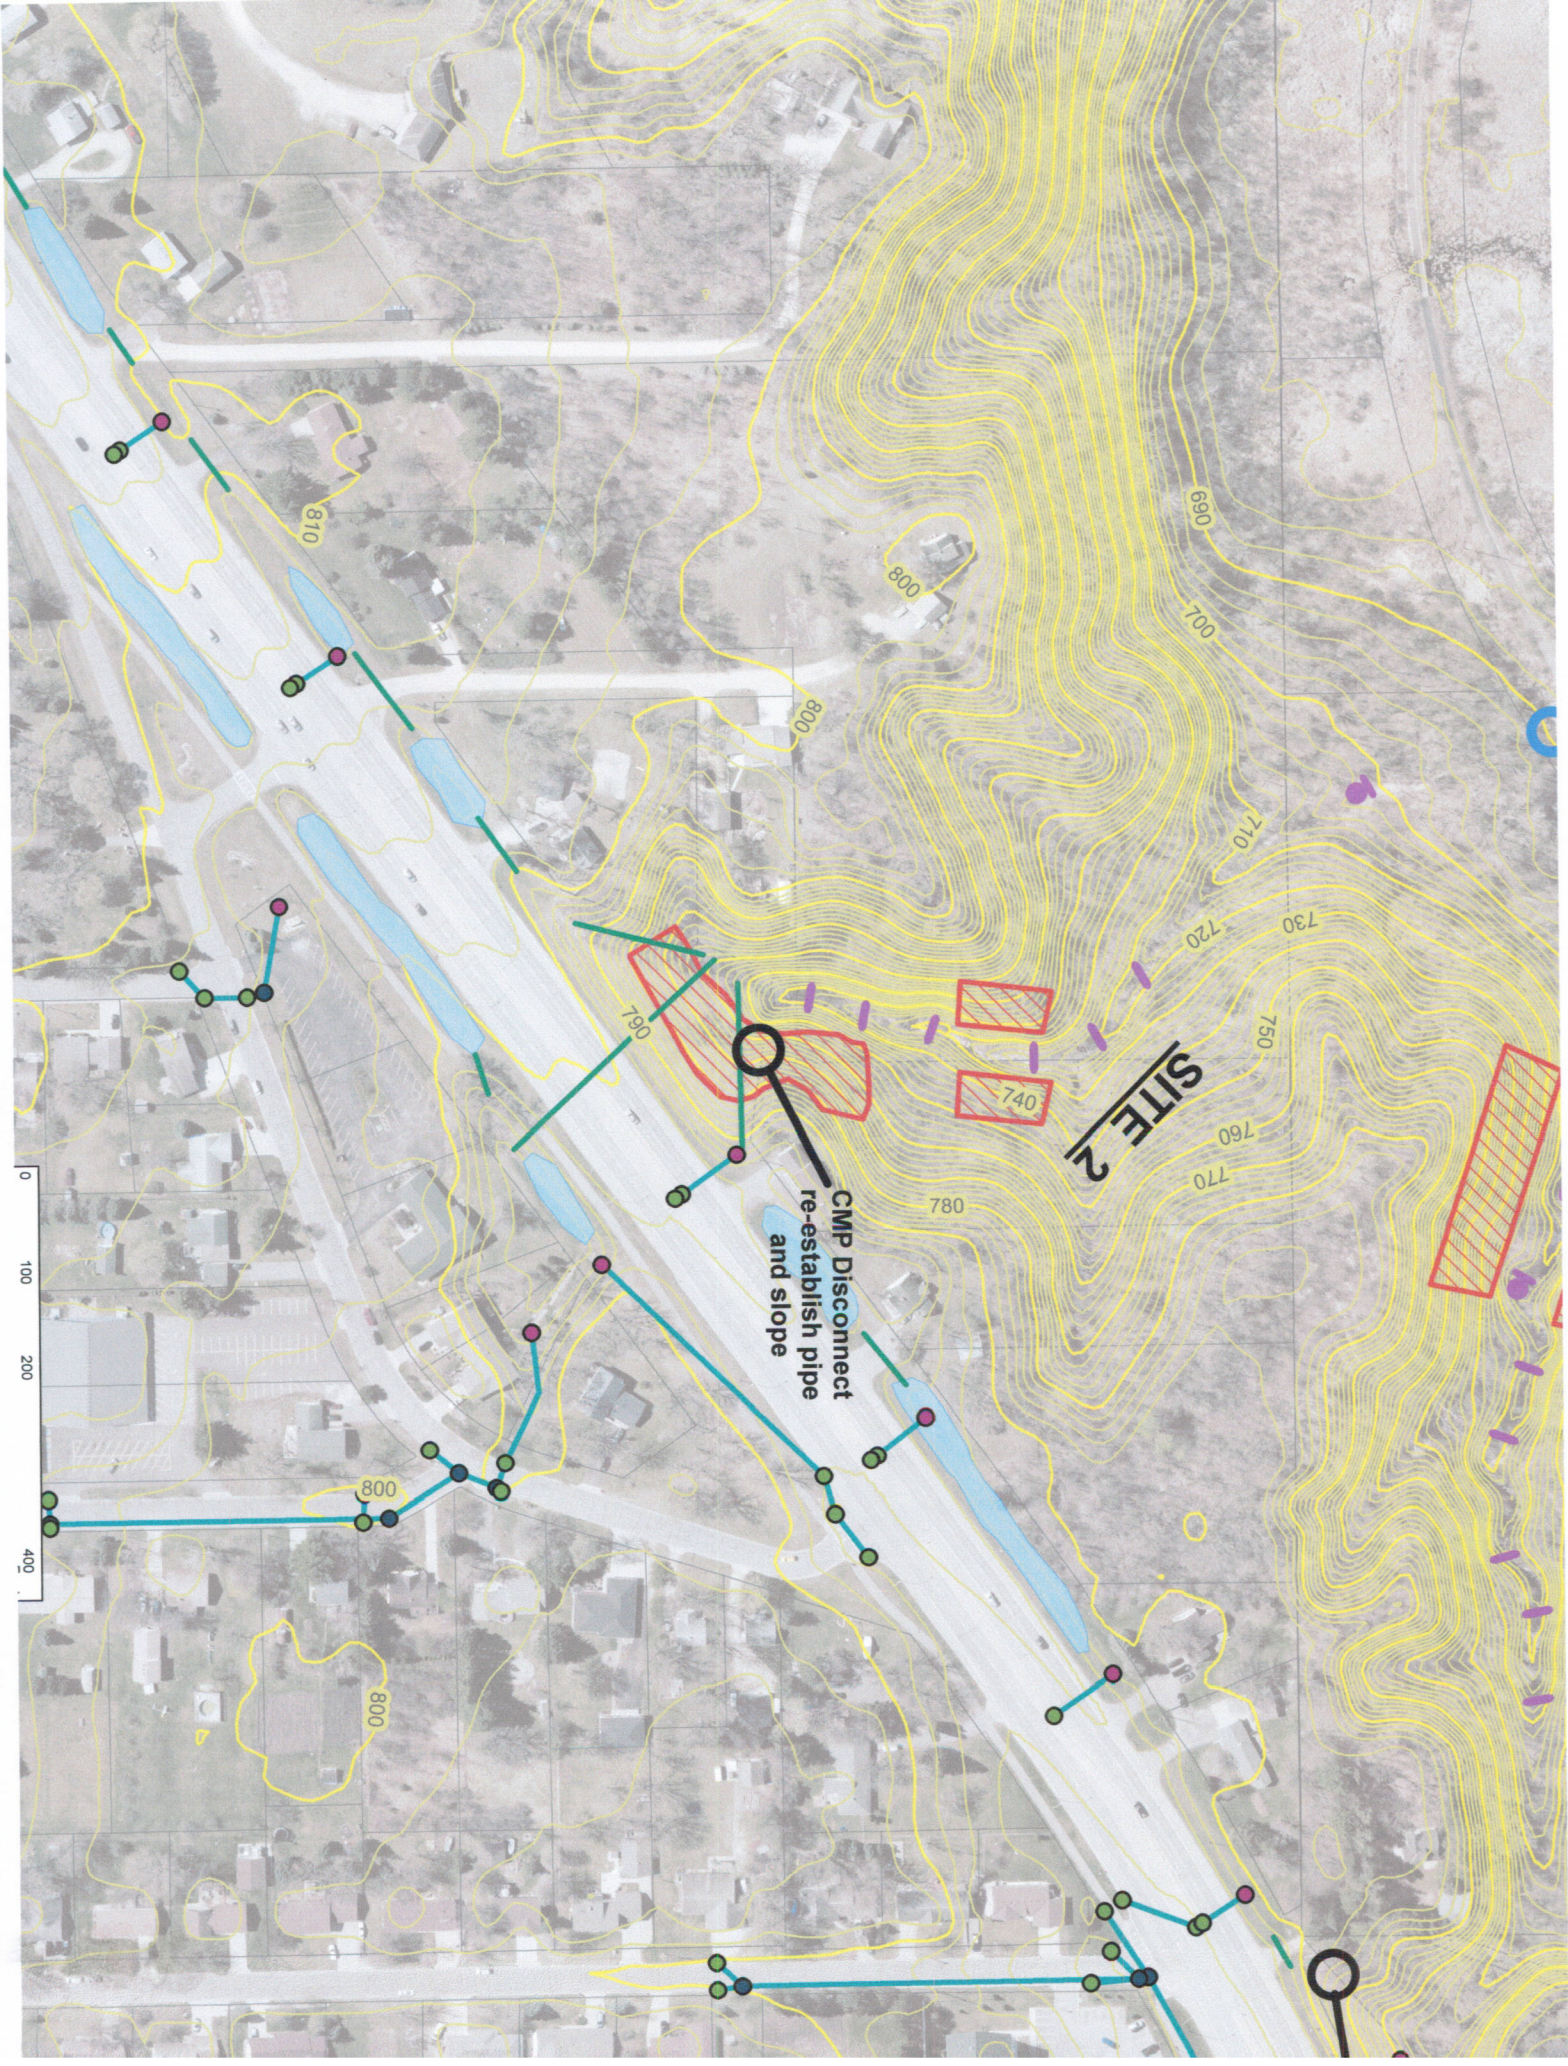
One of the challenges with upper watershed retention is finding suitable land to hold the water. In Figure 2, a number of locations along either ditch of TH 61 were identified as potential infiltration areas. A common method of retaining water in roadside ditches is to create small earthen or rock dams in the ditch. The dams would have very gradual slopes to prevent them from being a hazard to cars which have left the roadway or to ATVs and snowmobiles. These types of treatments could be used or modifications to the existing driveway culverts in the area could be made to simply use the driveways as dams, instead. Simply raising the upstream end of each driveway culvert by a foot or so can create shallow basins in the ditch where infiltration can occur and water can be slowed before getting to the erosion sites. If the small dams are created instead of utilizing the driveways, care will need to be taken to monitor the integrity of these dams over time. Snowmobiles can quickly scar and damage the dams, rendering them ineffective. For this reason, the driveway treatments are preferred.

The second part of our approach at these two sites is a set of BMPs which include slope stabilization, rock checks, inline infiltration basins and sediment traps. Figure 2 shows the proposed location of these treatments. The concept for these BMPs is much the same as the upstream approach, slow the water down and utilize the sandy soils to infiltrate as much as possible. Figure 5 illustrates in detail some of the specific recommended BMP's.

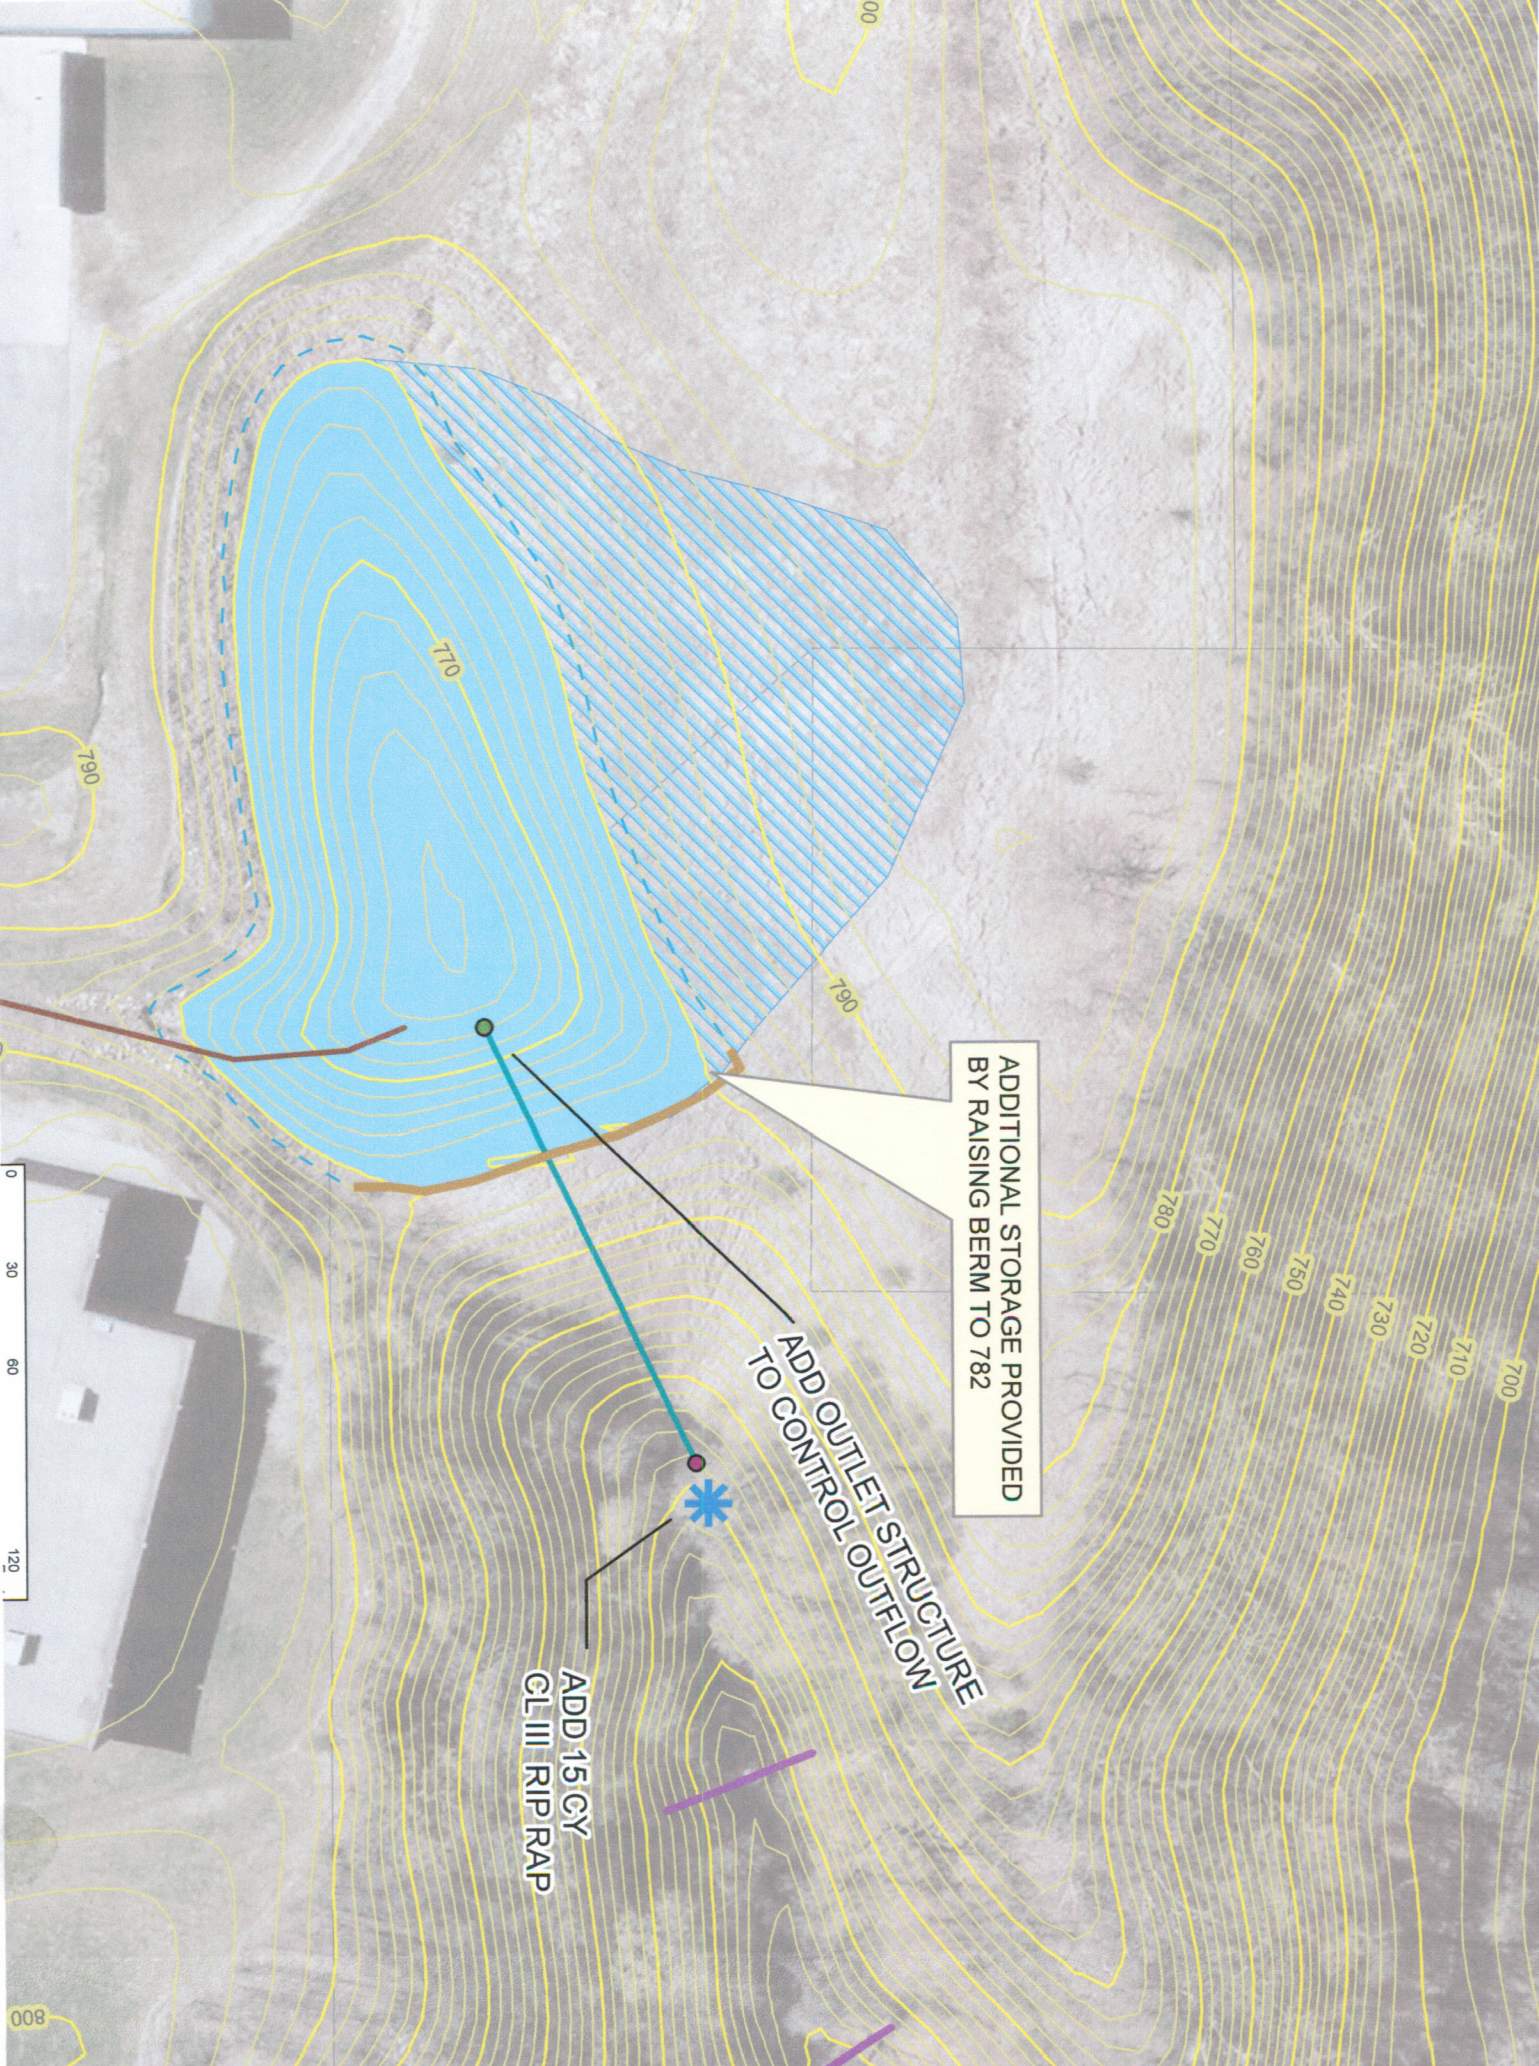
Similar to Sites 1 and 2, ditch checks and other inline BMPs will also help control the erosion of this ravine. Locations and notes are illustrated in Figure 3.

ADDITIONAL STORAGE PROVIDED
BY RAISING BERM TO 782

ADD OUTLET STRUCTURE
TO CONTROL OUTFLOW

ADD 15 CY
CL III RIP RAP

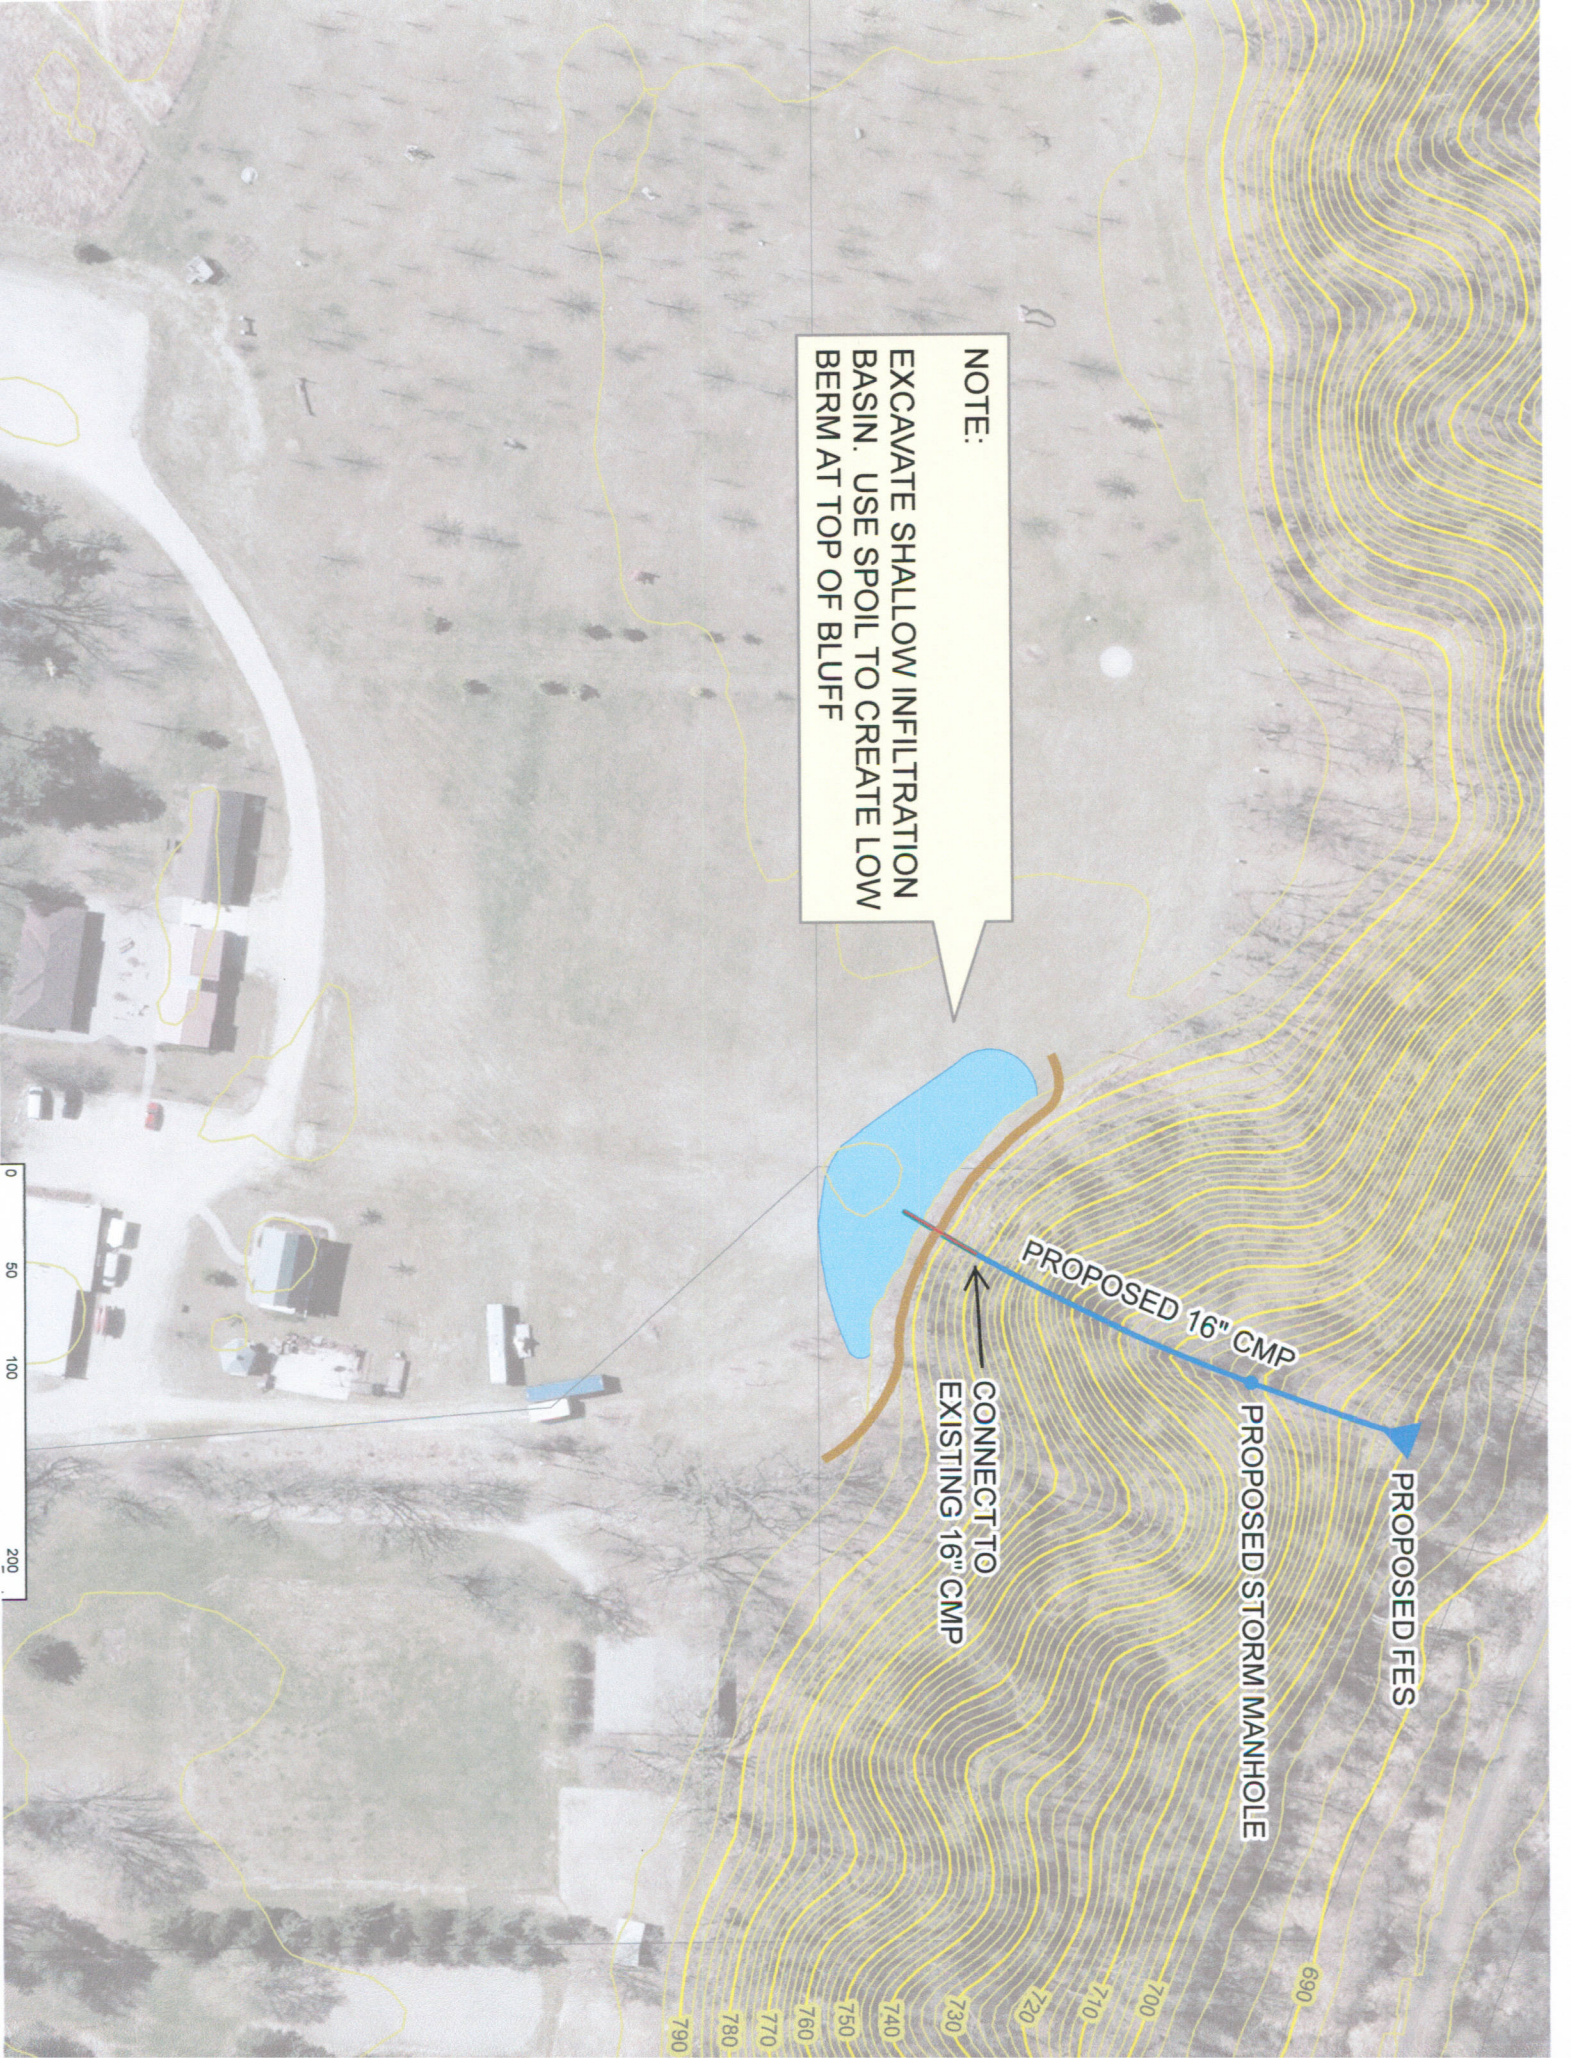
Site 4, is just to the west of Site 3 and is a shorter section of ravine with erosion downstream of an existing 16-inch culvert. In this area, the top of the bluff is a flat plateau, sloping gradually toward the bluff. The flow channelizes in some locations and leads to the culvert inlet. There are two recommendations here to help minimize erosion. First, the extension of the 16-inch culvert to the bottom of the bluff would eliminate the current situation where the pipe outlets in the middle of the slope. There is an opportunity to install a manhole near the bottom to allow a grade break in the pipe in order to flatten it out, slowing the water down before it exits onto the ground.

Second, excavating a shallow infiltration area below the elevation of the existing inlet pipe would also eliminate some of the runoff. The spoil from this excavation could be used to create a low berm along the edge of the bluff to eliminate surface runoff from going over the top. Recommended improvements are illustrated in Figure 4. Energy reducers in the pipe and dissipaters at the outlet could be considered also.

NOTE:
EXCAVATE SHALLOW INFILTRATION
BASIN. USE SPOIL TO CREATE LOW
BERM AT TOP OF BLUFF

PROPOSED FES

PROPOSED STORM MANHOLE

PROPOSED 16" CMP

CONNECT TO
EXISTING 16" CMP

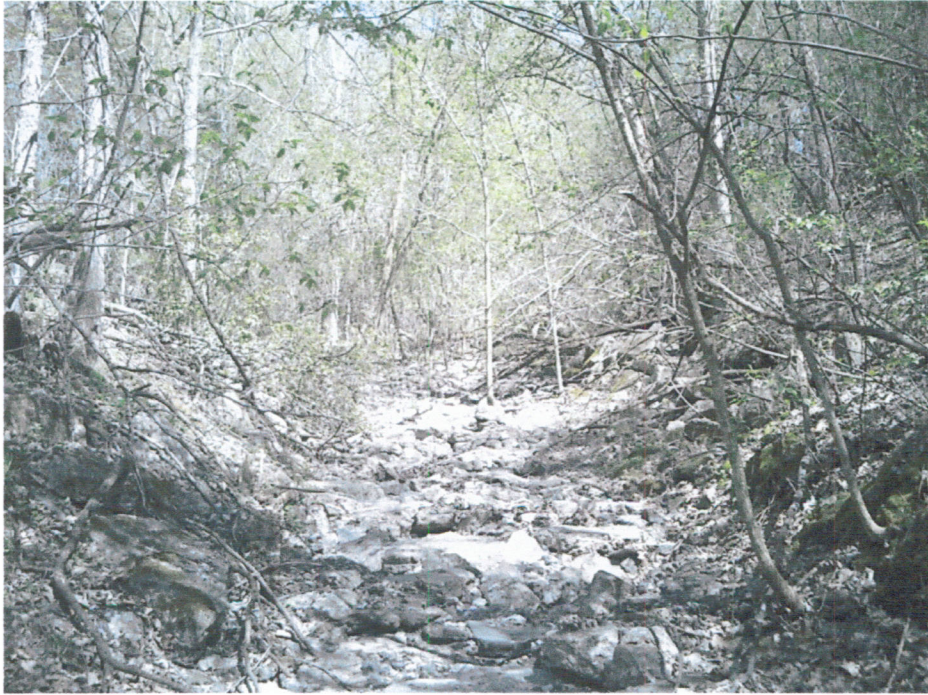
Photo File Name: **107**

Notes: **Rock bottom, stable, looking upstream**

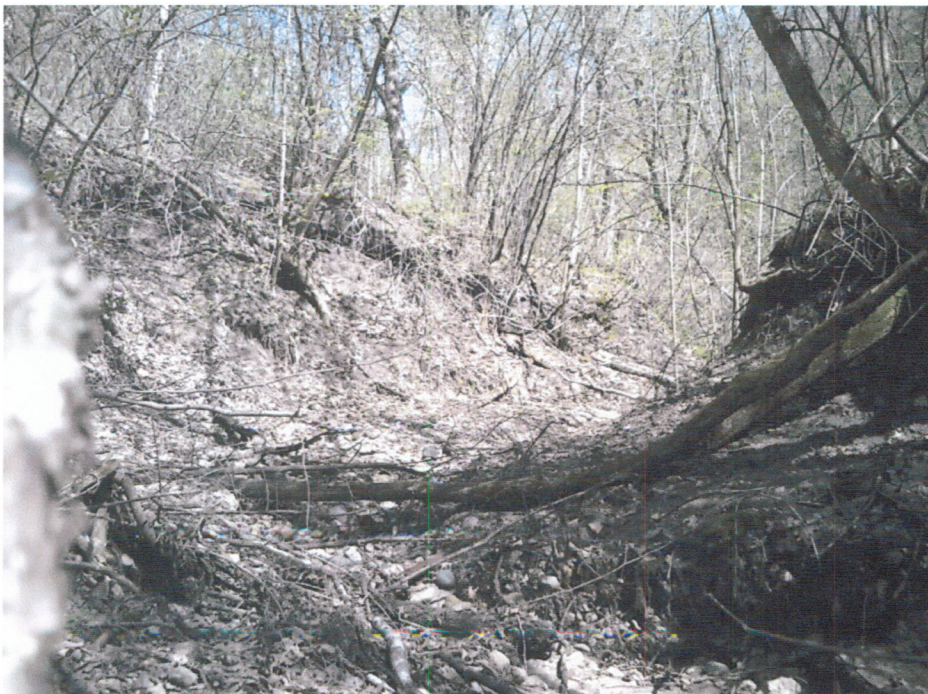
Photo File Name: **111**

Notes: **Back erosion, potential rock check, 16-ft bottom**

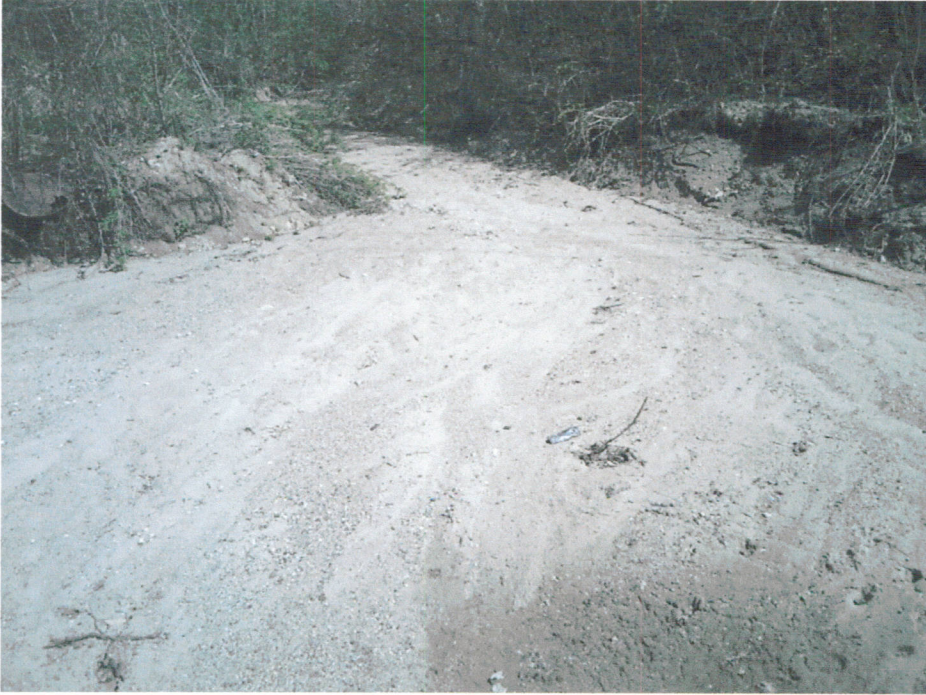
Photo File Name: **114**

Notes: **Sand wash, looking upstream**

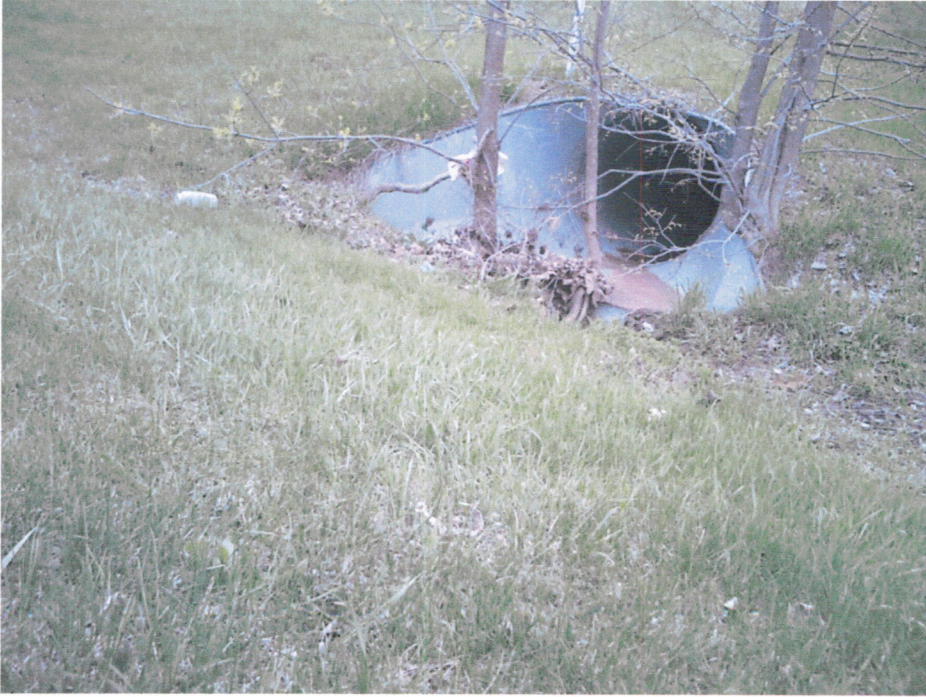
Photo File Name: **100**
Notes: **Outlet end, no storage**

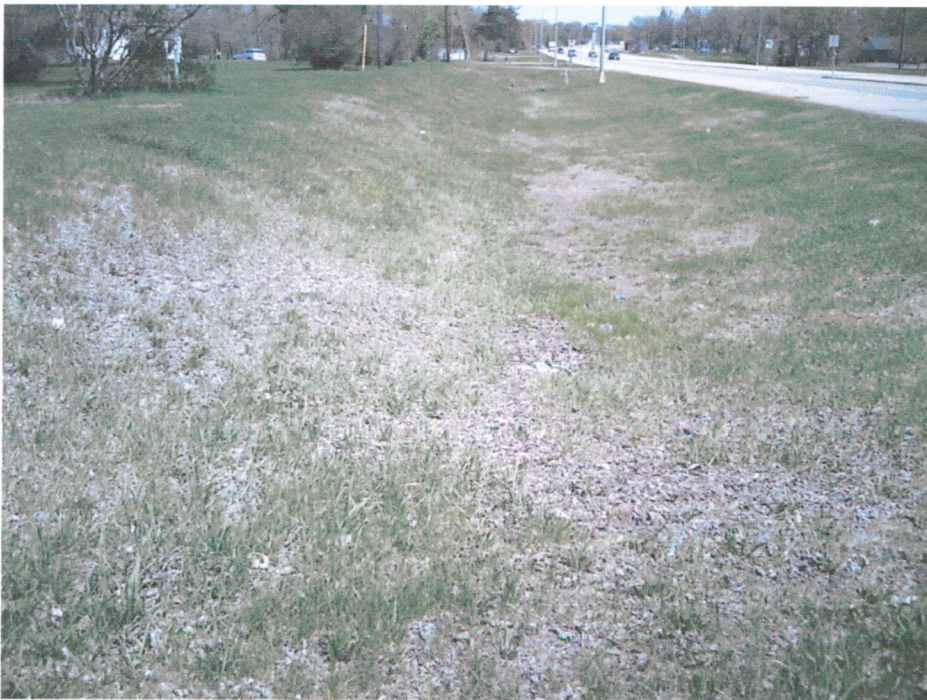
Photo File Name: **103**
Notes: **Typical road swale**

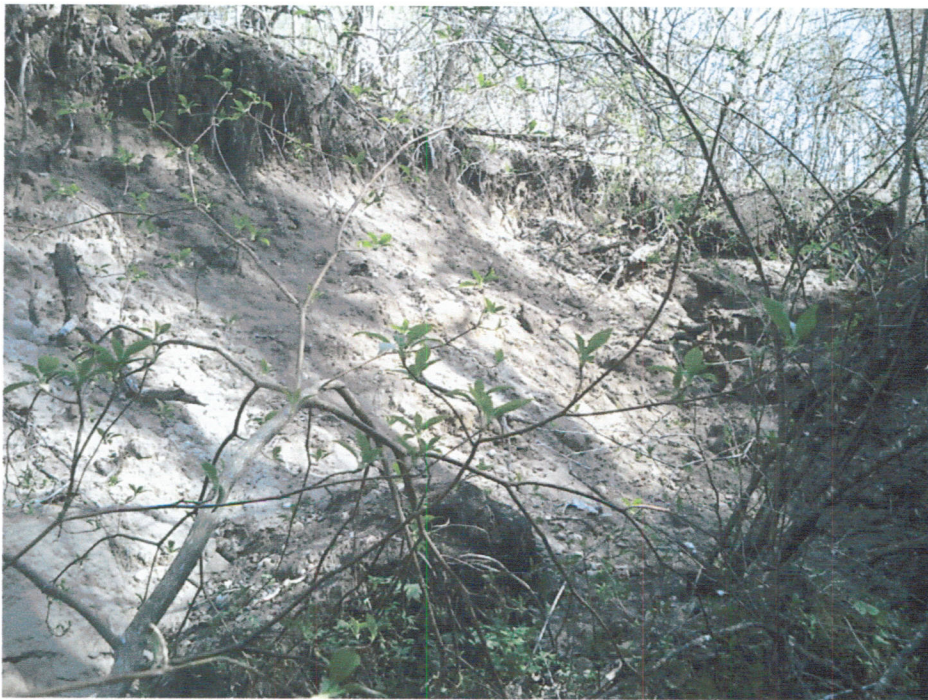
Photo File Name: **116**
Notes: **Sand slope, 1.5:1**

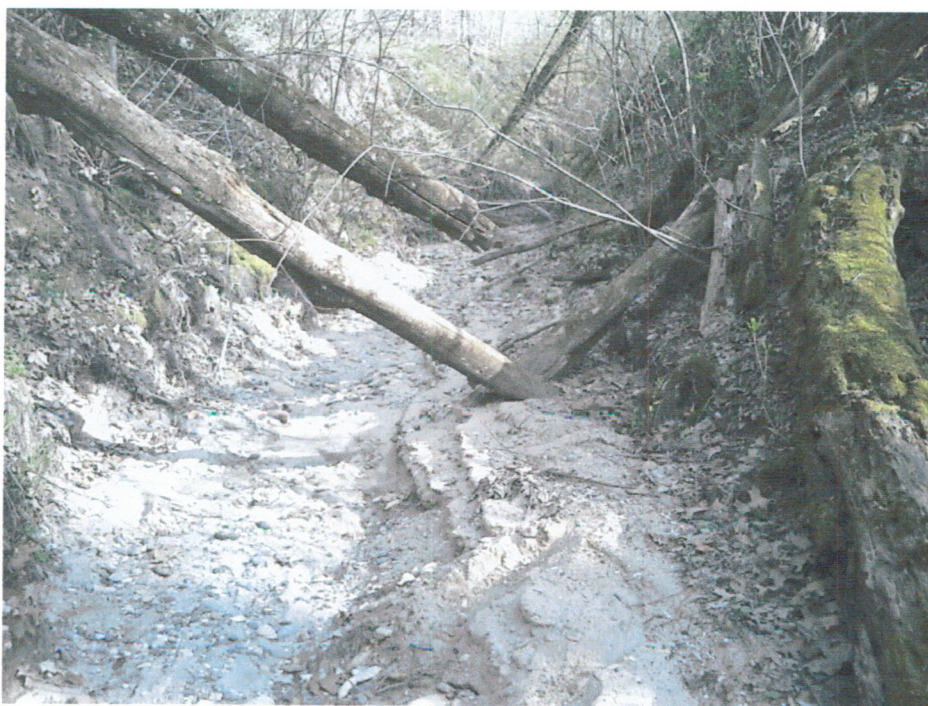
Photo File Name: **119**
Notes: **channel looking upstream**

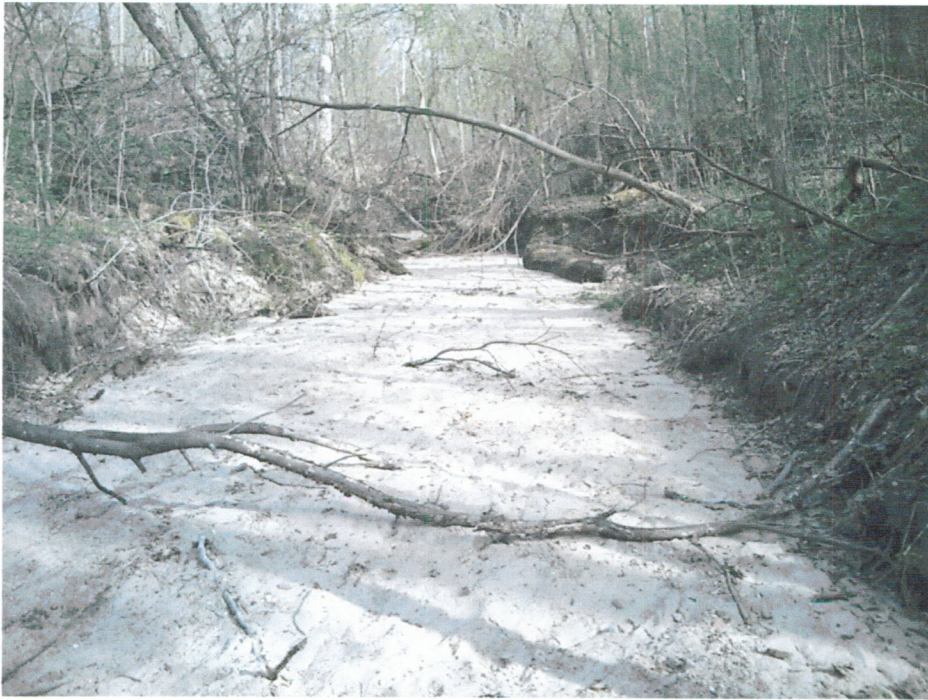
Photo File Name: **122**

Notes: **sediment deposits, looking upstream**

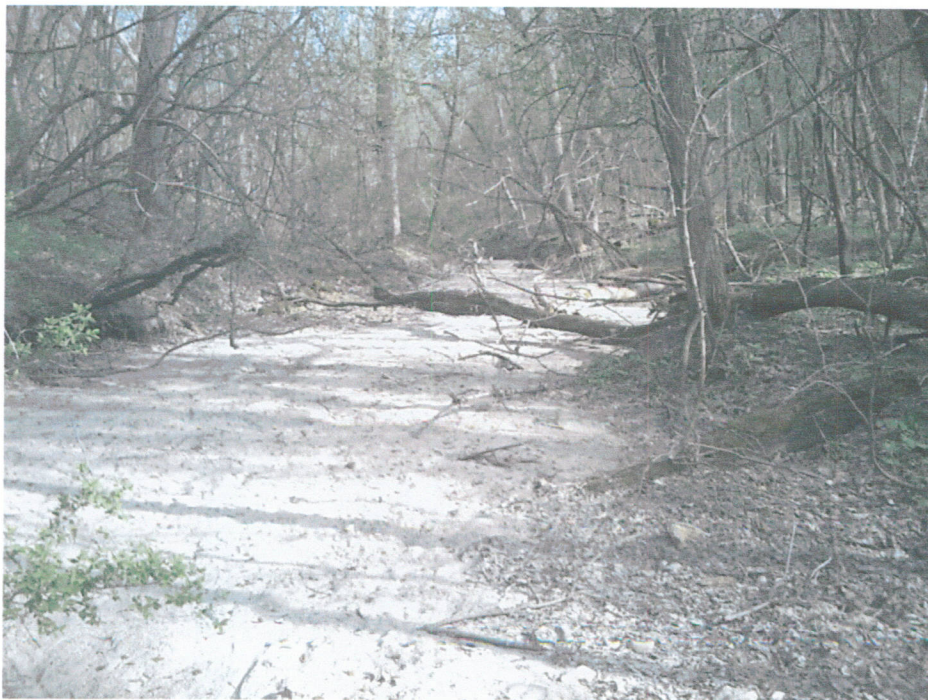
Photo File Name: **123**

Notes: **Looking upstream, potential sediment trap**

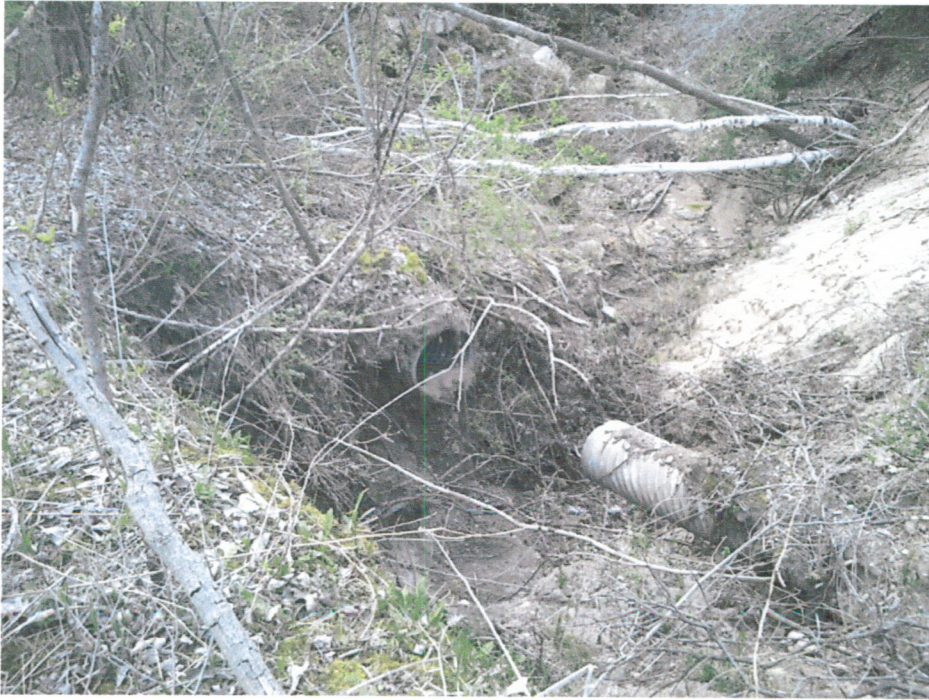
Photo File Name: **125**

Notes: **Pipe outlets**

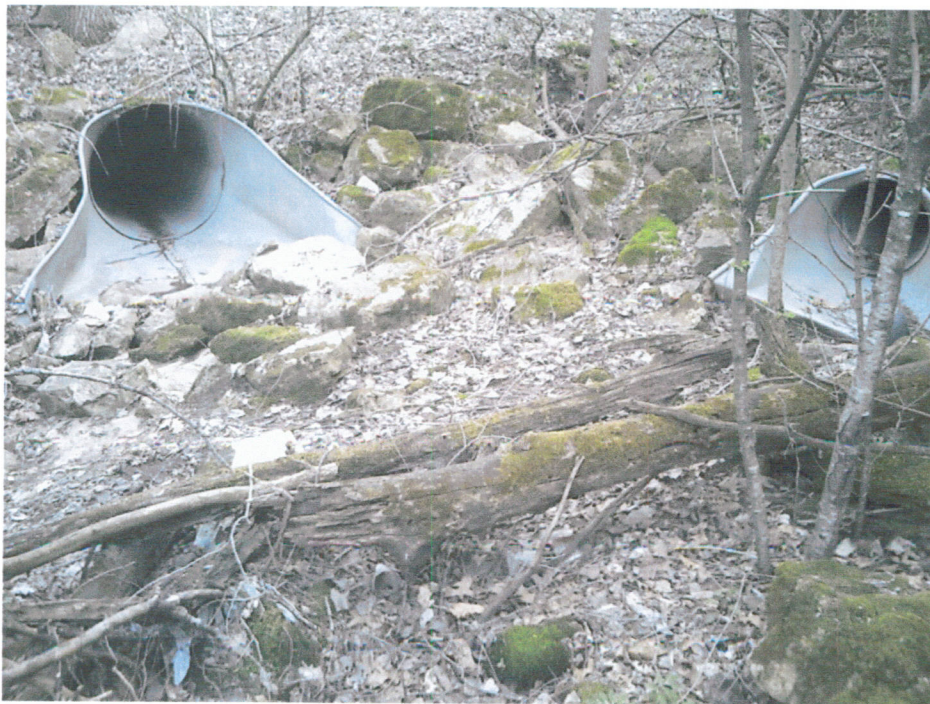
Photo File Name: **127**

Notes: **Culvert pipe ends**

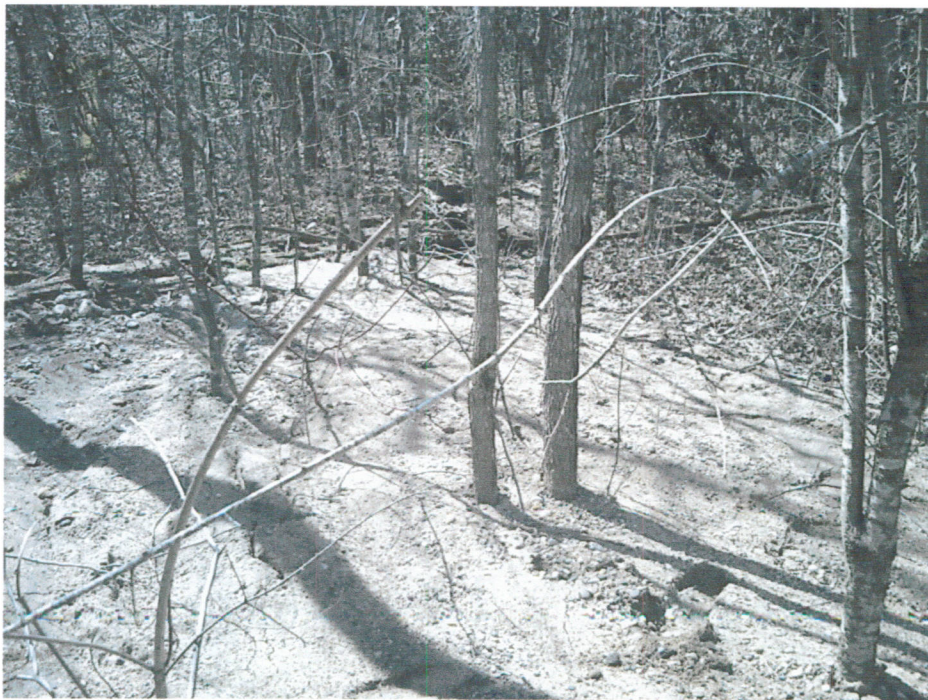
Photo File Name: 12

Notes: **Side channel looking upstream**

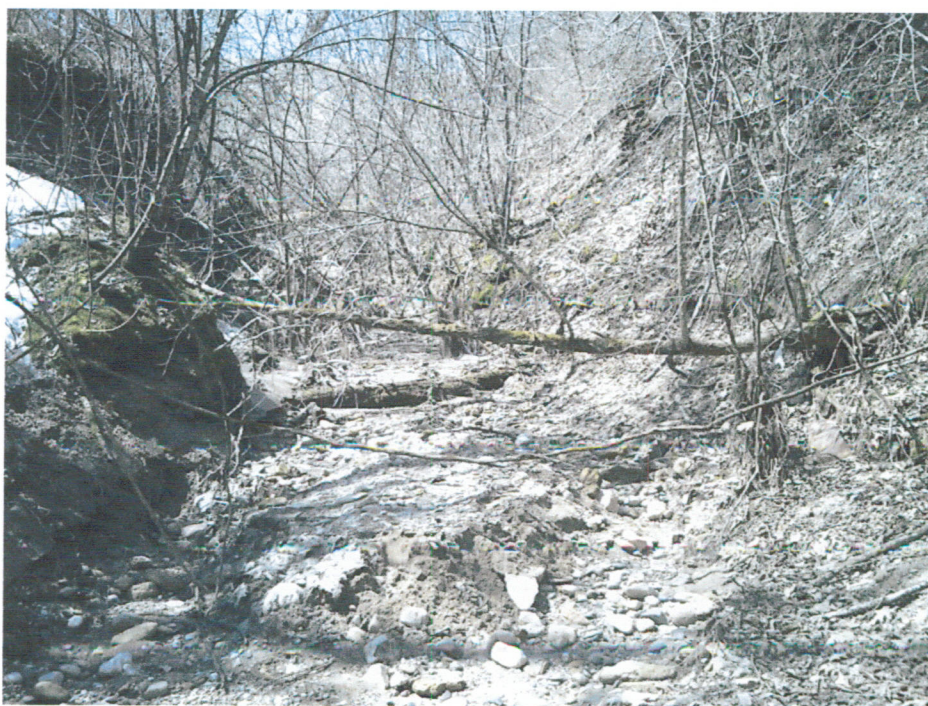
Photo File Name: 13

Notes: **Channel cutting**

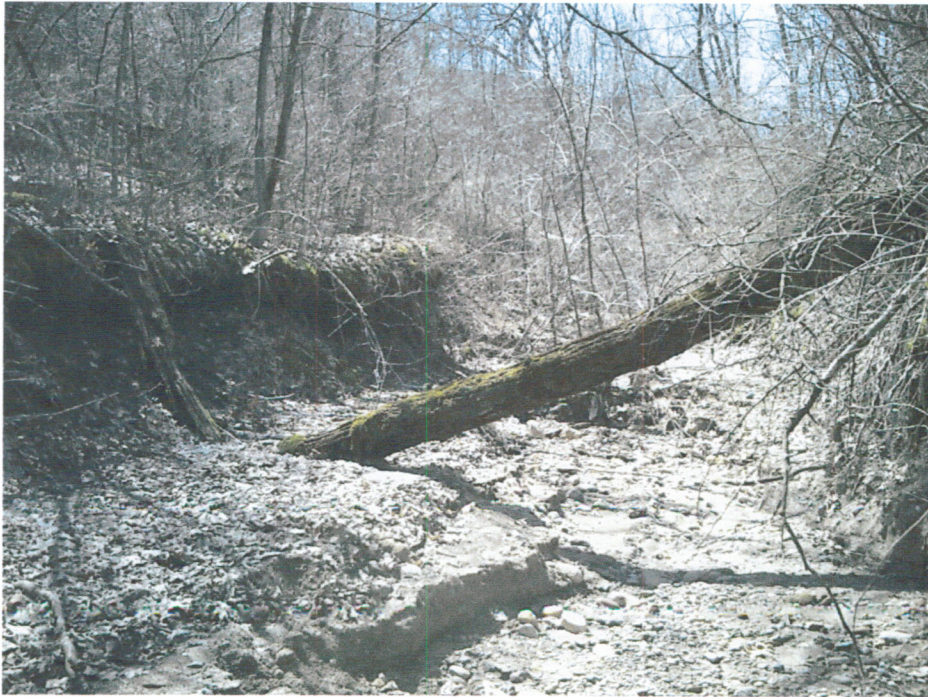
Photo File Name: 15
Notes: **channel cut - 17-ft wide**

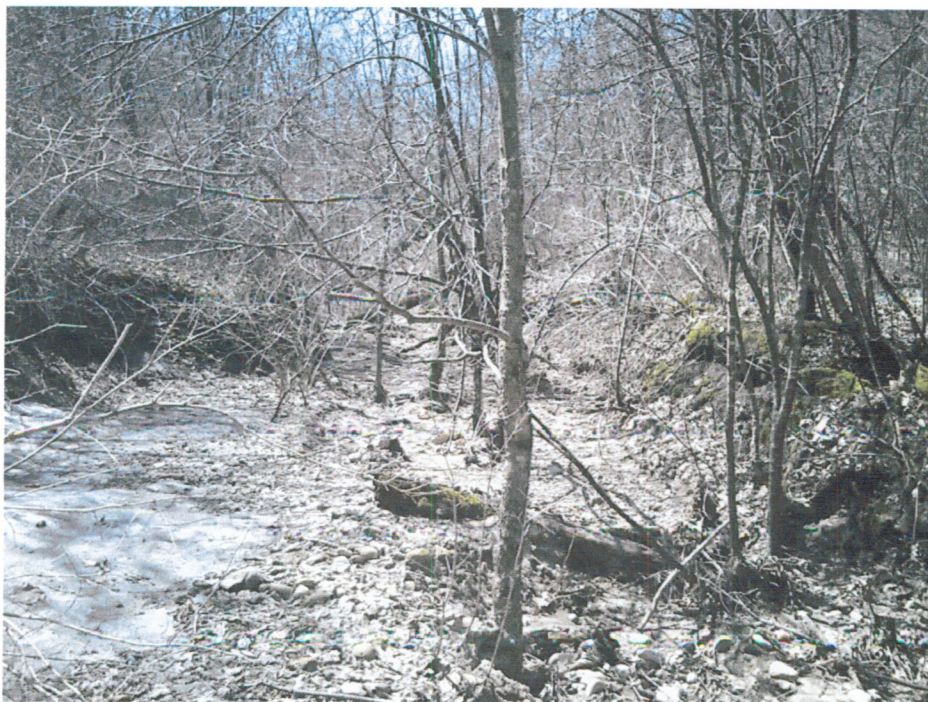
Photo File Name: 16
Notes: **Sandy soil outwash**

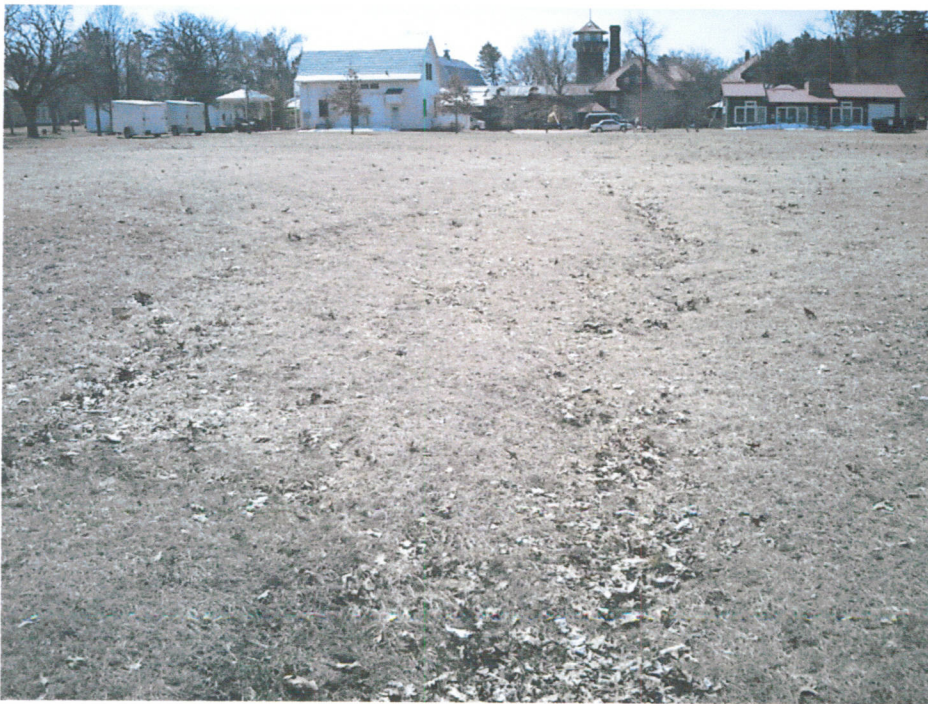
Photo Label No.: 2

Notes: **Drainage swale leading to the ravine, looking south**

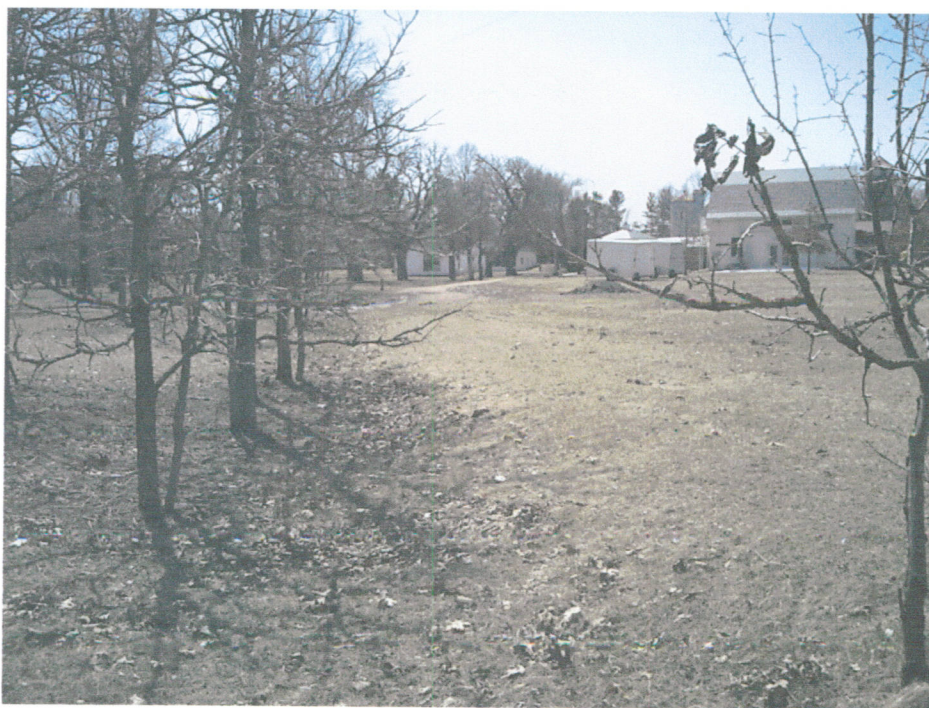
Photo File Name: 4

Notes: **Drainage swale leading to the ravine, looking south**

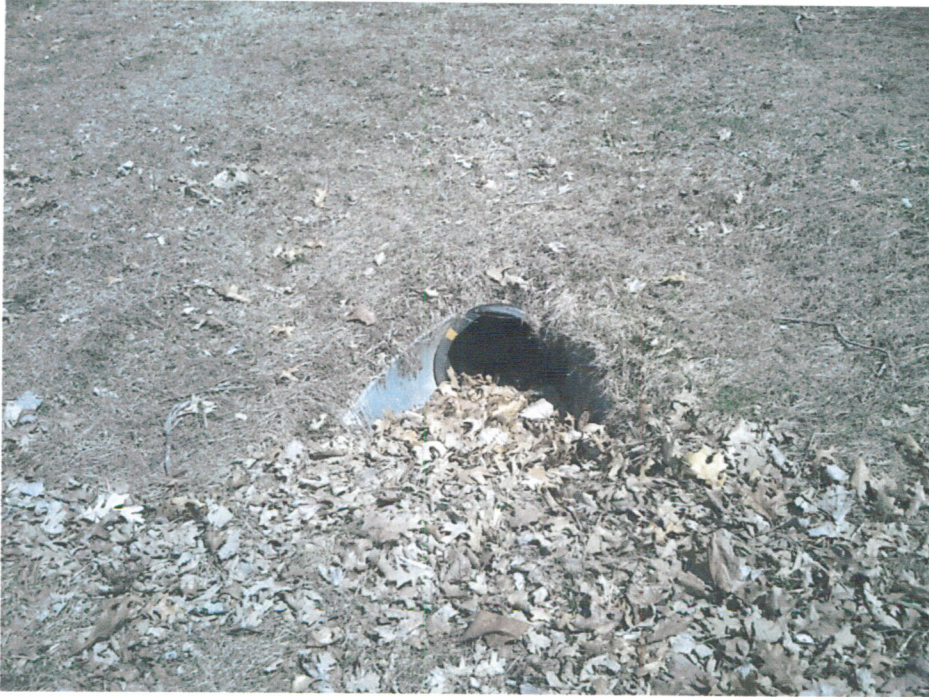
Photo File Name: 5
Notes: culvert end

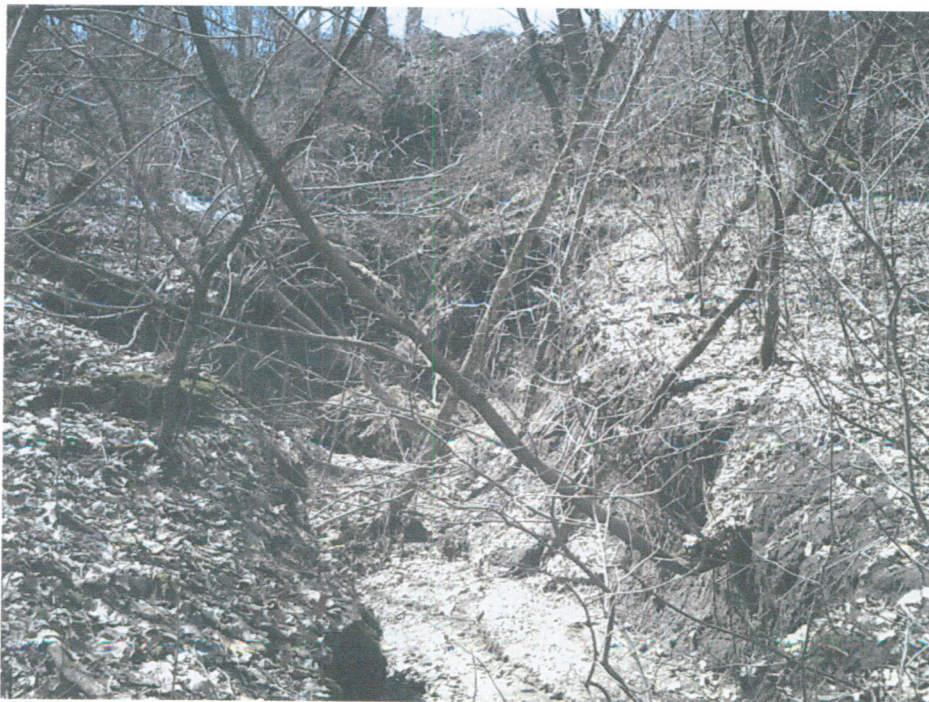
Photo File Name: 6
Notes: Main erosion, drop structure pipe, sandy soil
