To:	Scott Roepke Cannon Valley Trail Association	From:	Gary Morien Authors: Gary Morien, John Smyth, Mark Statz, Dan Edgerton
File:	Stantec Project No. 193801880	Date:	August 22, 2013

Reference: Technical Memorandum - Cannon Valley Trail Erosion Repairs

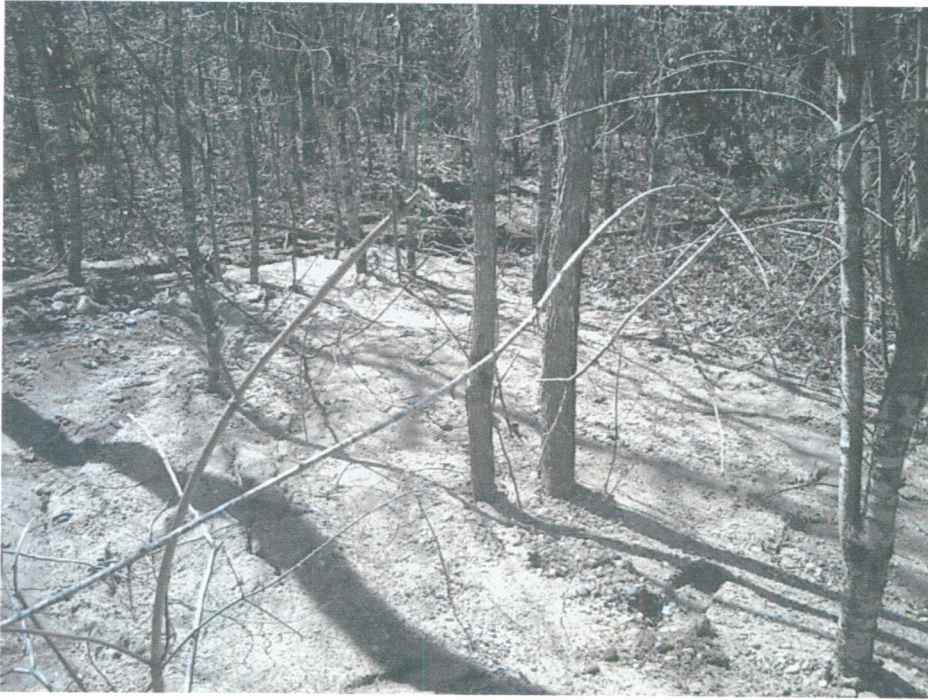
Photo File Name: 9

Notes: **Sand deposits, lower end**
