To:	Scott Roepke Cannon Valley Trail Association	From:	Gary Morien Authors: Gary Morien, John Smyth, Mark Statz, Dan Edgerton
File:	Stantec Project No. 193801880	Date:	August 22, 2013

Reference: Technical Memorandum - Cannon Valley Trail Erosion Repairs

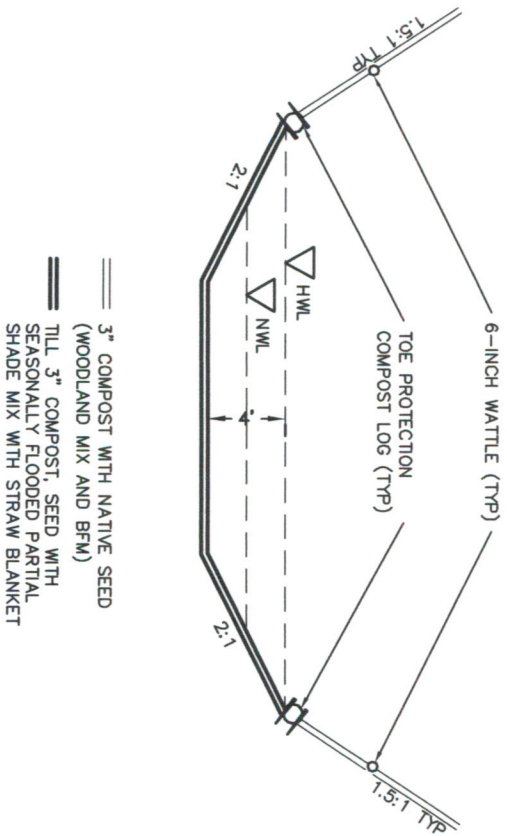
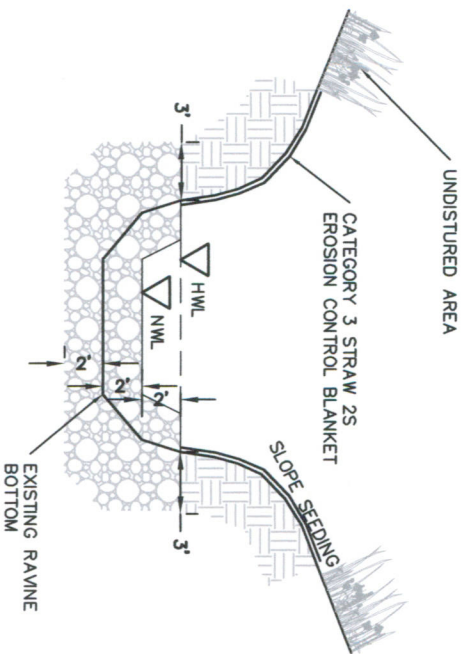
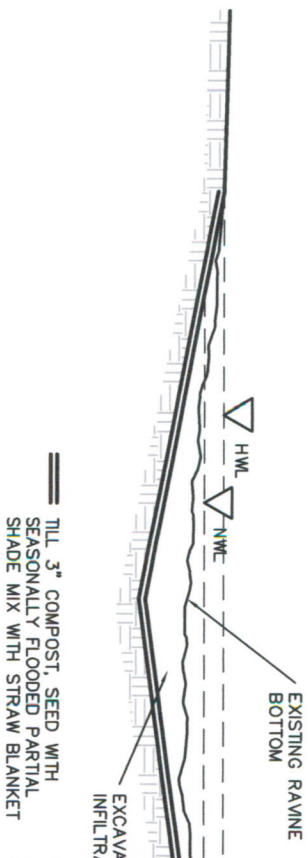
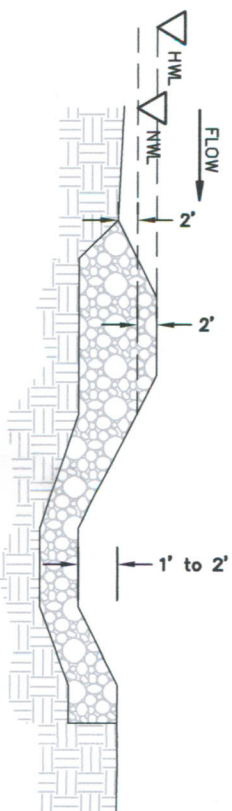
TYPICAL CROSS SECTION

CHECK DAM

TYPICAL PROFILE

The second part of our approach at these two sites is a set of BMPs which include slope stabilization, rock checks, inline infiltration basins and sediment traps. Figure 2 shows the proposed location of these treatments. The concept for these BMPs is much the same as the upstream approach, slow the water down and utilize the sandy soils to infiltrate as much as possible. Figure 5 illustrates in detail some of the specific recommended BMP's.
