FEASIBILITY REPORT

on Improvements to the
Cannon Valley Trail

Presented to the
Cannon Valley Trail
Joint Powers Board

January 13, 2017

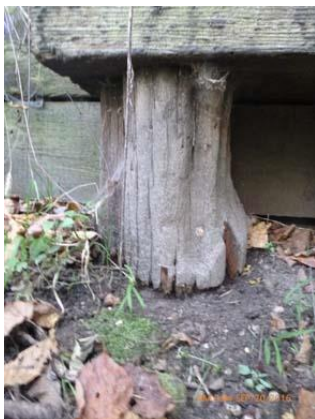
Figure 1.3 East Abutment - Rotting and splitting pile with section loss at ground line.

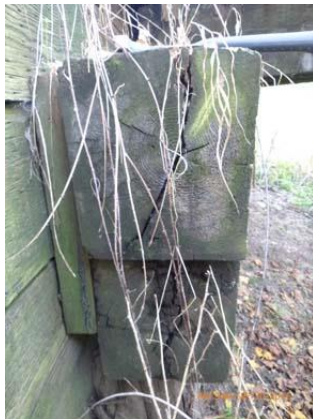
Figure 1.4 East Abutment - Splitting and rotating cap with 2x4 inch insert.

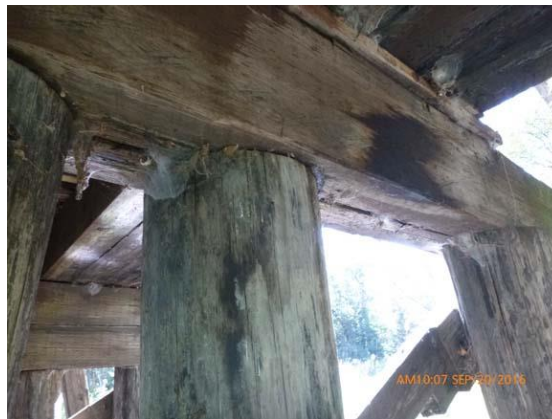
Splitting of the pier cap is severe and there is local crushing under both beams.

Figure 1.5 Pier 1 - Severe split running the entire length of the pier cap.

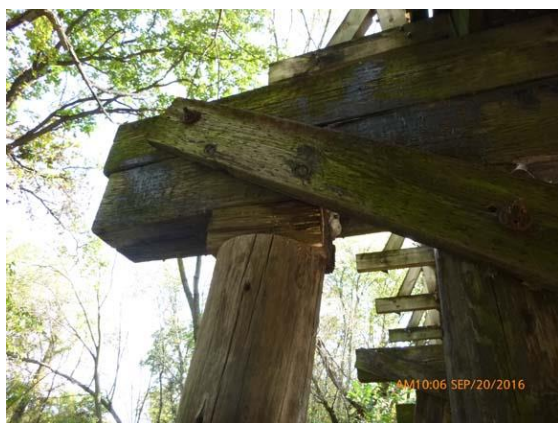
Figure 1.6 Pier 2 - Wood block installed to fill the gap between top of pile and cap.

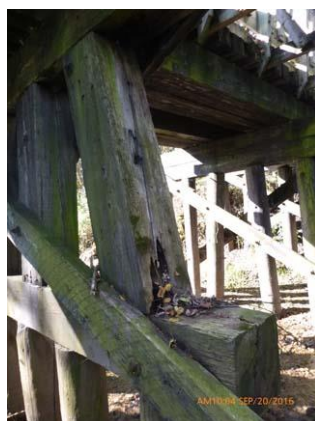
Figure 1.7 Pier 3 - Severe section loss and splitting of the north column.

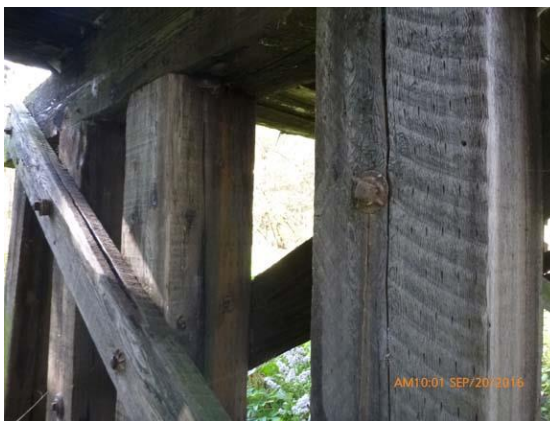
Figure 1.8 Pier 6 - Most columns and bracing are splitting.

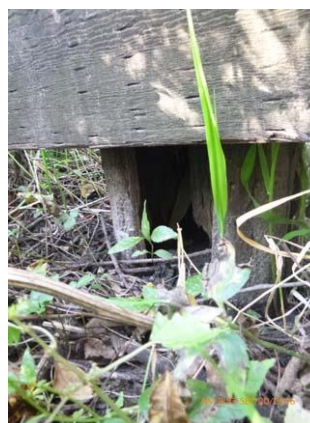
Figure 1.12 Pier 8 - Severe section loss inside the south pile.

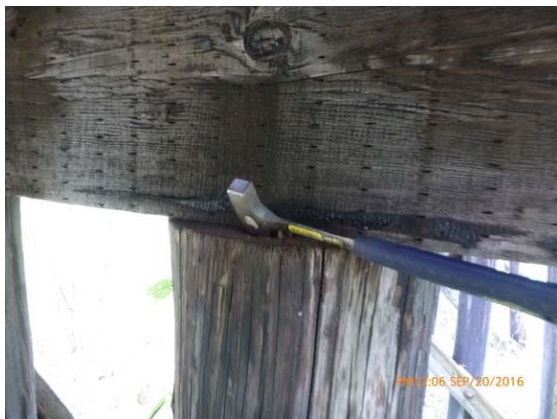
Figure 2.4 Pier 1 - Pile rotting and becoming hollow.

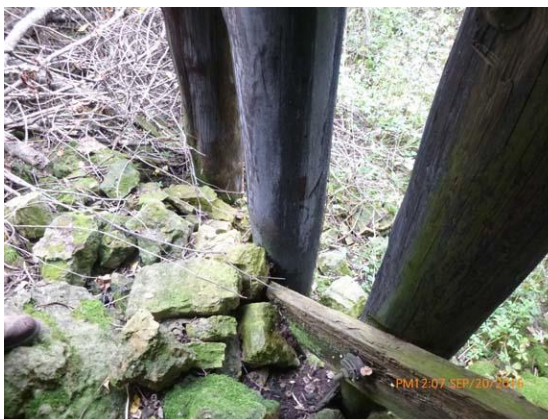
Figure 2.5 Pier 1 - Rip-rap crushing ends of cross bracing.

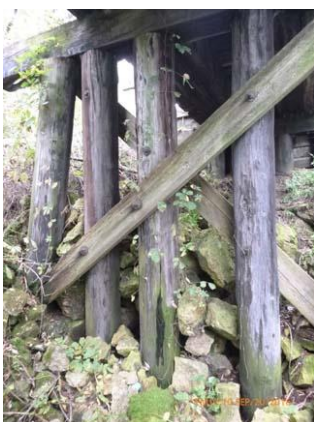
Figure 2.6 Pier 1 - Rocks stacked against piles and cross braces.

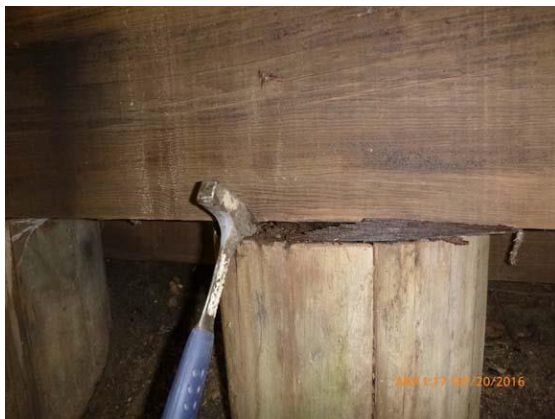
Figure 3.2 Piles - On the west abutment piles are rotting and splitting.

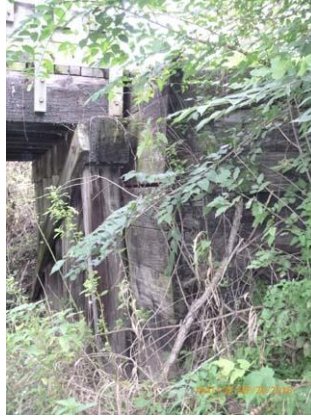
The top three backing planks at the east abutment have rotated behind the cap resulting in a 1 inch gap between the third and fourth plank. All piles have moderate splitting, and the cross brace is also splitting near the ground line. The north end of the cap exhibits decay and the south wingwall has shifted.

Figure 3.4 East abutment - Rotation of the backing planks.

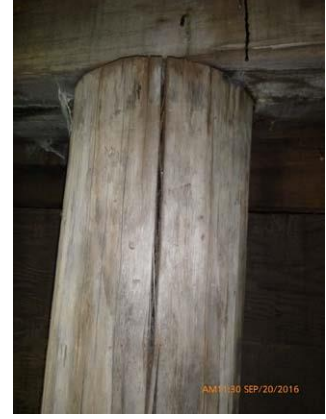
Figure 3.5 East abutment - Most piles are splitting and have internal decay.

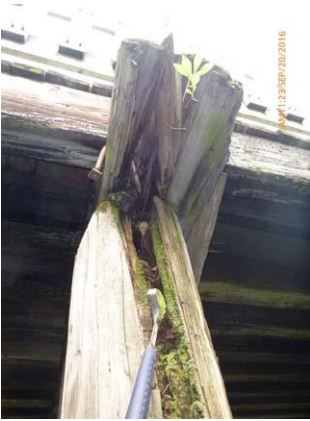
Figure 3.6 Pier 2 - North portion of pile cap and north pile have severe decay and have failed.

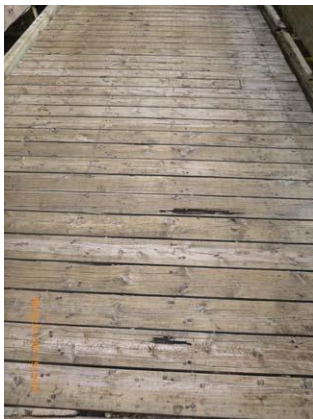
Figure 5.1 Deck - Moderate deterioration throughout and patches.

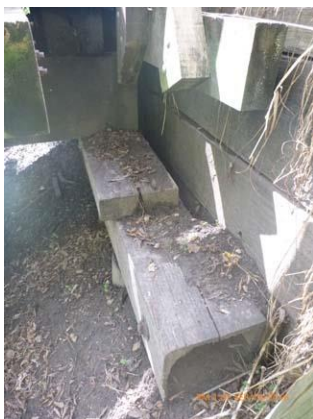
Figure 5.3 West abutment - decay and / or movement of bearing spacers, pile cap and backing planks.

The pile cap at the west abutment is splitting and has section loss at the ends; the north end is becoming hollow. The bearing spacers on the cap are decaying, splitting and shifting away from the backing planks. All piles are decaying and showing signs of section loss; the south pile has 80% section loss.

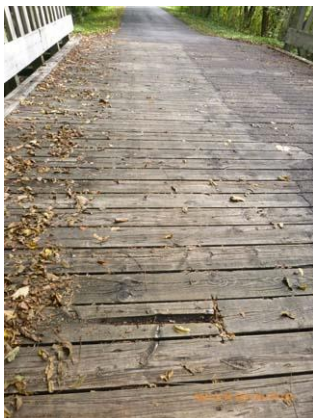
Figure 12.1 Deck - Minor deck plank splitting.

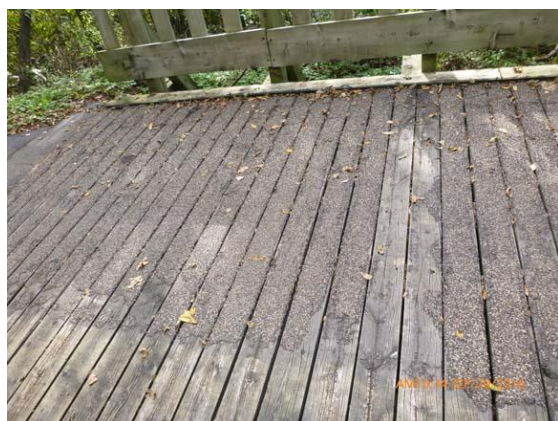
Figure 12.2 Deck - Overlay experiment with some material loss.

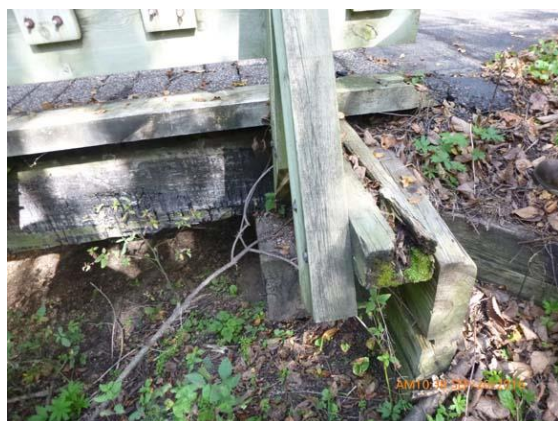
Figure 12.3 Deck - Floor beam at southeast corner rotting.

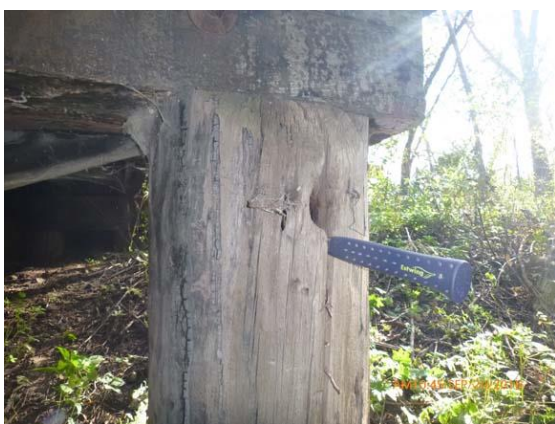
Figure 12.6 Piles - South pile of the east pier becoming hollow and rotting.

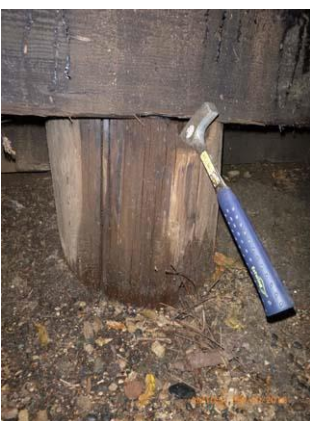
Figure 12.7 Piles - West abutment center piles are becoming hollow and rotting.

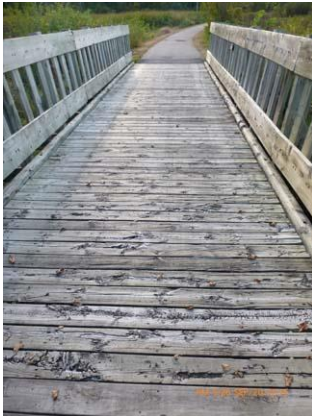
Figure 13.1 Deck - Moderate deterioration of the deck planks.

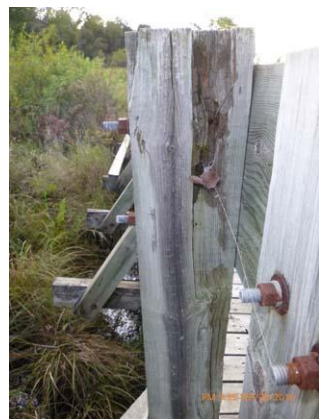
Figure 13.3 Rail - Deterioration of the rail posts at the south side.

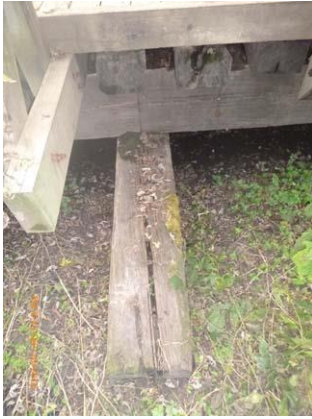
All pier caps have minor to moderate splits at the ends. The piles have minor decay and splits throughout.

Figure 14.4 Pier cap - Moderate split at pile cap.

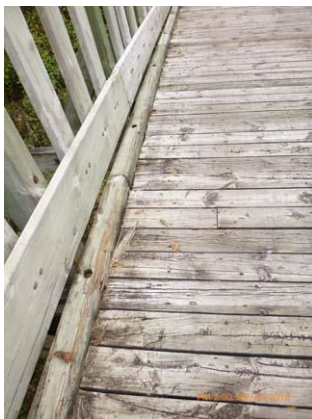
Figure 15.1 Deck - Damage to curb section.

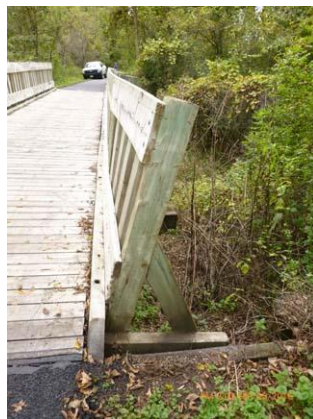
Figure 15.2 Rail - Failed floor beam supporting rail and kicker allowing for railing deflection.

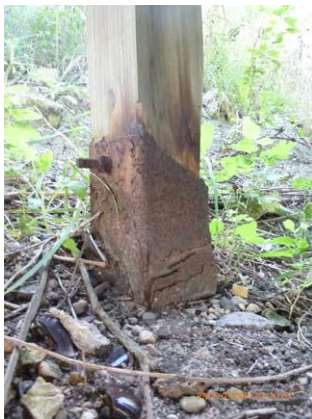
Figure 19.3 Footing brackets - Several footing brackets have active corrosion and section loss.

The piers are in good condition. There is significant corrosion and moderate section loss of the brackets connecting the posts to the footings at the second and third pier from the east; minor corrosion on the other piers. These brackets do not need immediate replacement but their condition should be monitored closely. Some posts have minor splitting. The riprap placed around some of the footings on the north side is holding well and performing as it should, avoiding scour around the footings.

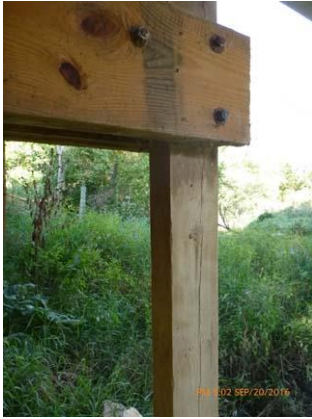
Figure 19.4 Pier posts - Minor splitting on some pier posts.

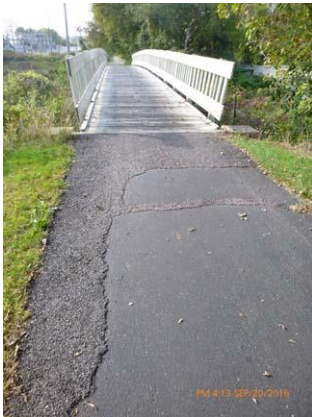
Figure 20.1 East approach - Extensive patching of the bituminous approach.

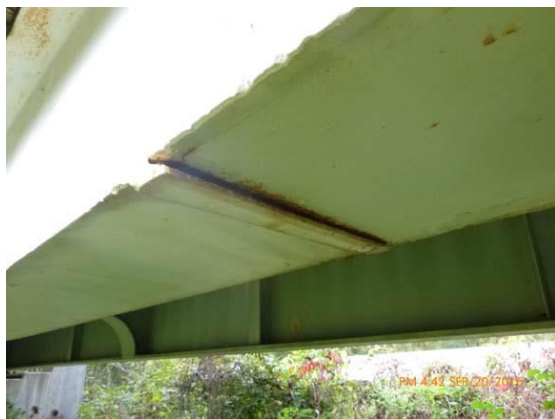
Figure 20.2 Beam - Construction joint separating.
